A STUDY OF BLUFF BANK EROSION FOR BUSTINS ISLAND, FREEPORT, ME

PREPARED: APRIL, 2018

UPDATED: MAY, 2019

CUMBERLAND COUNTY
SOIL & WATER
CONSERVATION DISTRICT

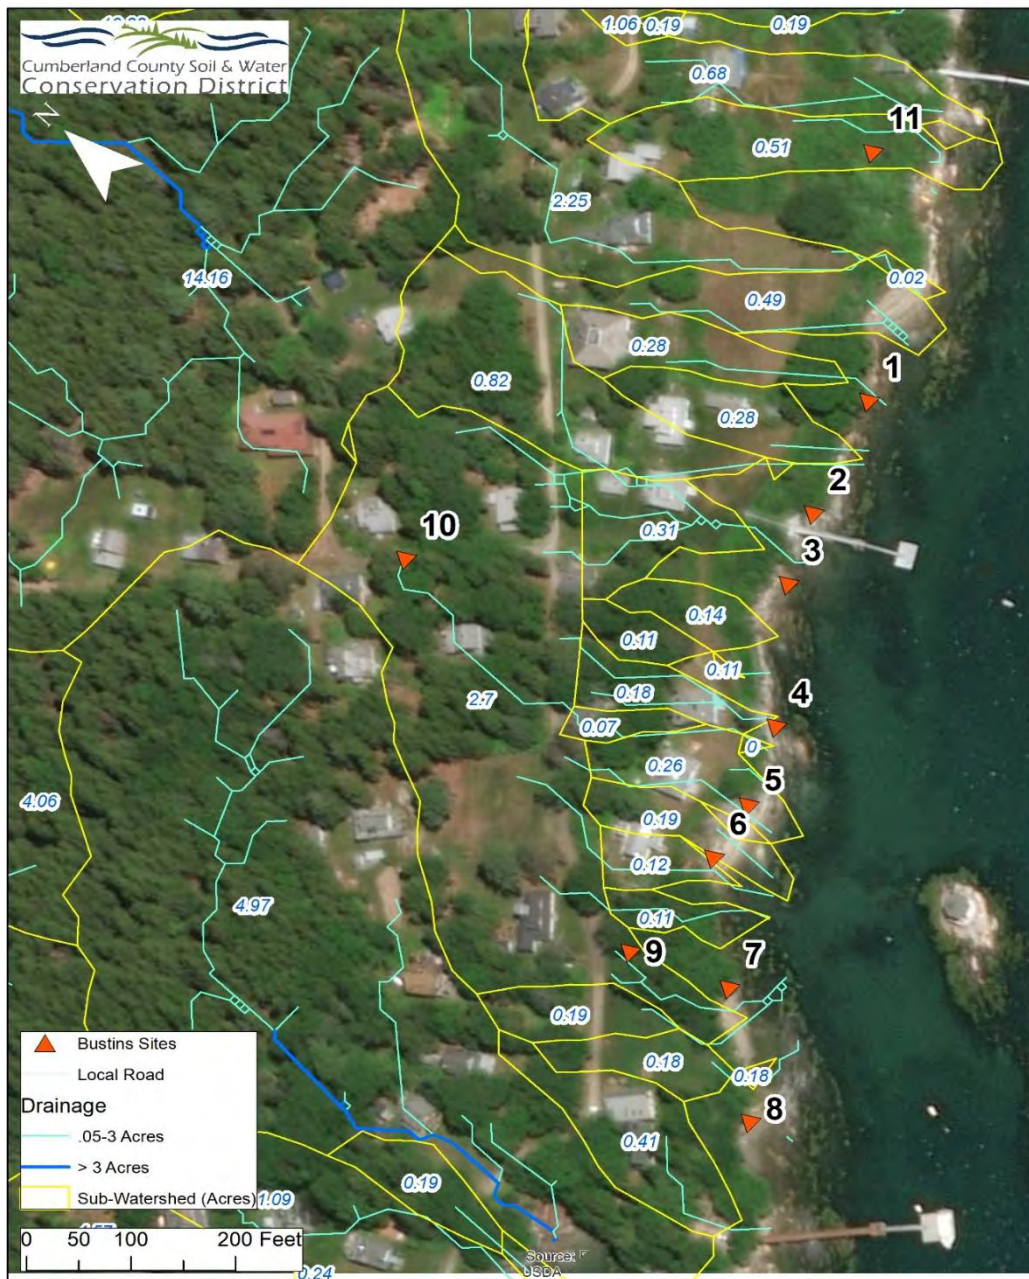
FIGURE 3. CASE STUDY LOCATION ON BUSTINS ISLAND. ASSESSMENTS OF STUDY SITES INCLUDED CONSIDERATION OF UPLAND SUBWATERSHED DRAINAGES, SHOWN WITH THIN YELLOW LINES. AREAS OF SUBWATERSHED DRAINAGES ARE SHOWN WITH BLUE ITALIC FONT. MODELED DRAINAGE PATHS ARE SHOWN IN THE BLUE LINES FOR EACH SUB-DRAINAGE.

- Changes to drainage patterns in the upland areas 9 and 10 have created concentrated flow along the roadway. This pattern change is contributing to surface drainage directed toward the top of the shoreline bank failures 7 and 8.
- Historically, shoreline areas 2 and 3 appear to have had similar erosive effects from culverts installed to redirect drainage patterns near the intersection of the roads.
