# Mare Brook Watershed Management Plan

2022-2032

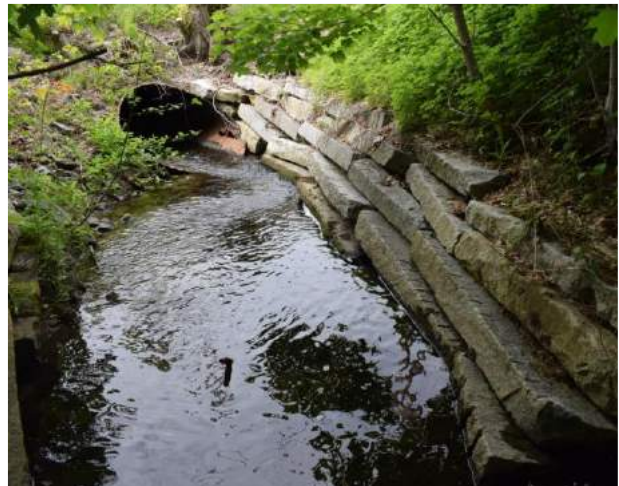
*Upstream view of granite blocks and Maine Street culvert outlet of Reach 9 during the geomorphic survey. Photo: John Fields*

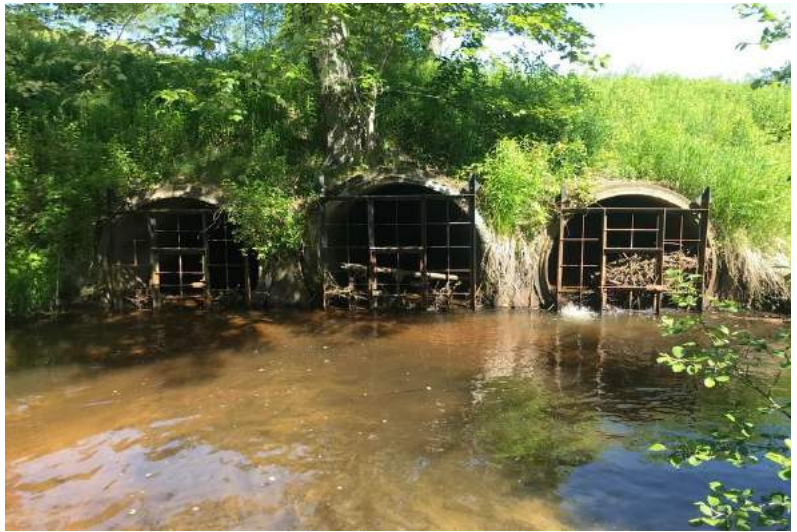
*Upstream view of culvert outlet under the former Brunswick Naval Air Station runway. Photo: John Fields*

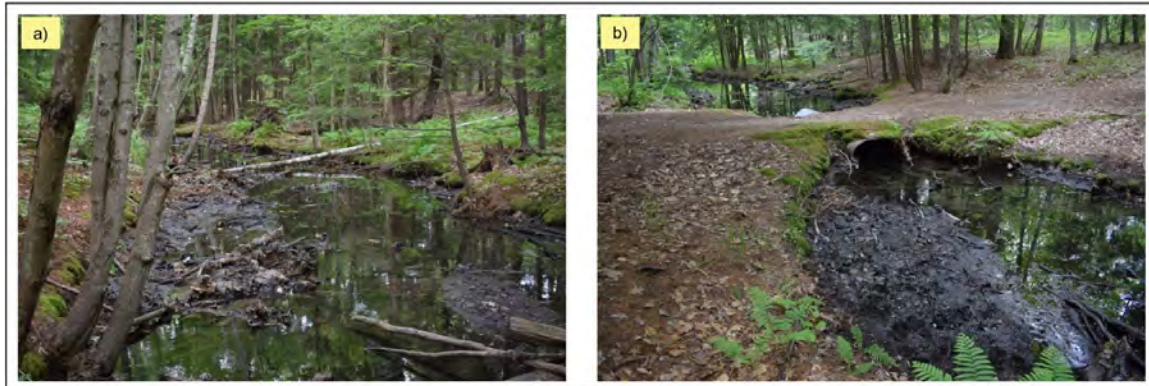
Figure 3. Reach 1 is a) overwidened with fine sediment accumulating along the margins and around wood and b) constricted by an undersized culvert causing further deposition.

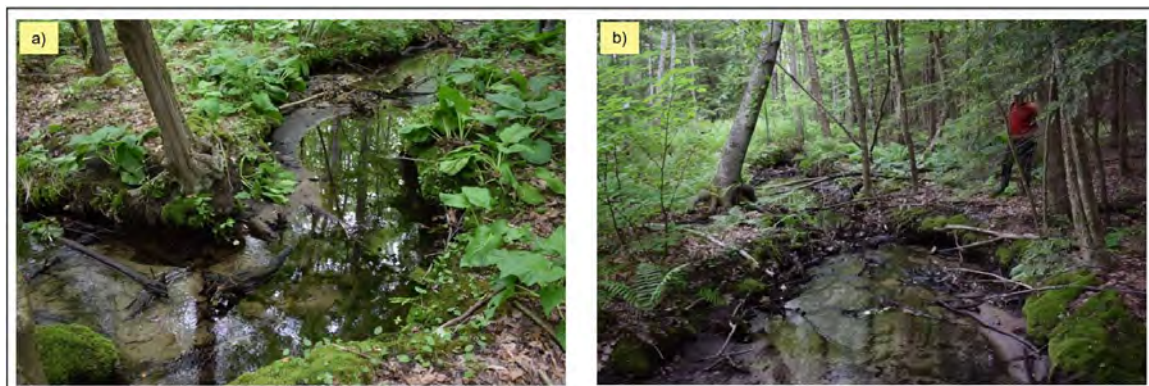
Figure 4. Reach 2 is a) sinuous and slightly incised with b) limited wood in the channel despite the forested floodplain.

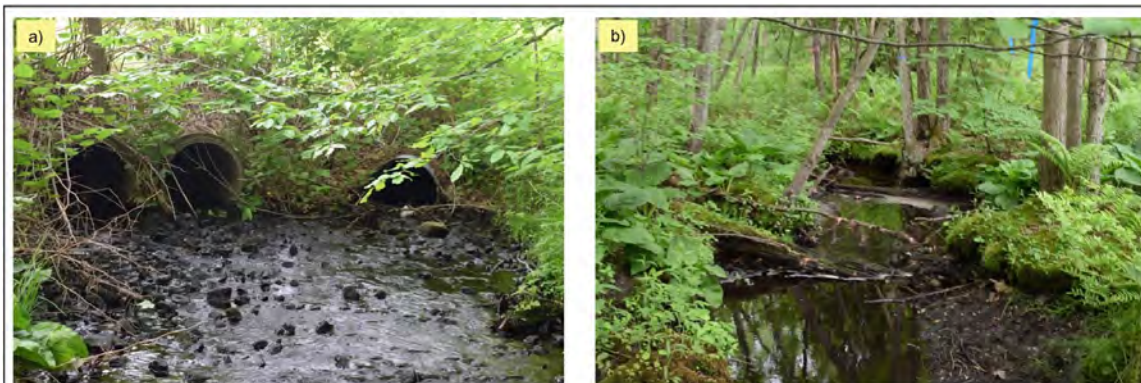
Figure 6. Reach 6 has a) an artificially armored bed at the outlet of the Baribeau Dr. culverts but b) further downstream appears in a near natural state.

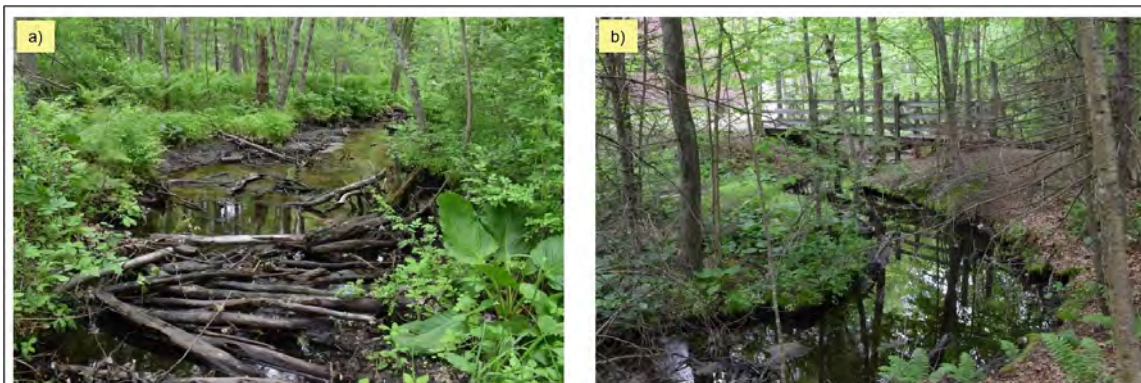
Figure 7. Reach 5 is a) a sinuous channel with lots of wood and sand deposition that b) is narrowed by fill at a pedestrian bridge.

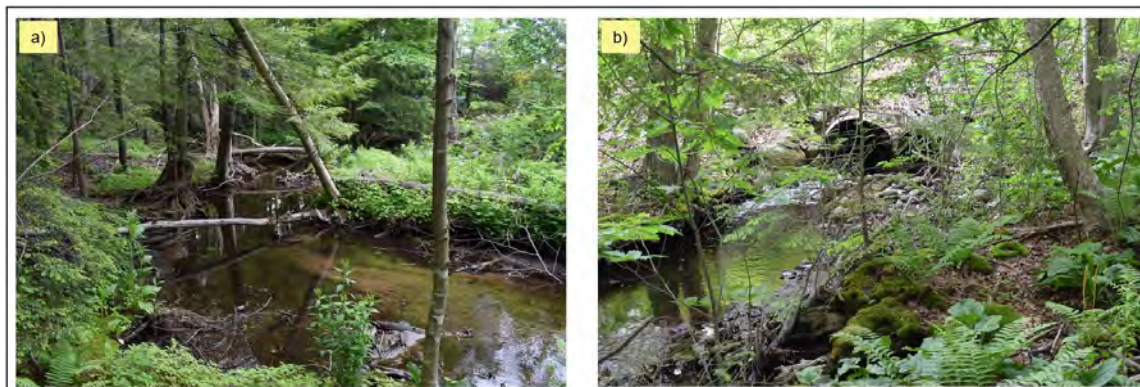
Figure 8. Reach 6 is a) wide with abundant sand/silt deposition and smaller pieces of wood in the channel with b) rock armor at the outlet of the Barrows St. culvert being the only unnatural feature in the reach.

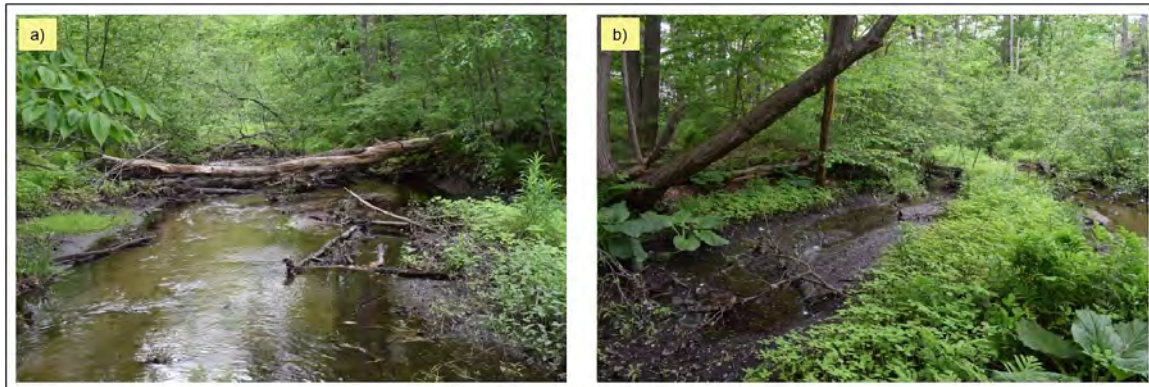
*Figure 10. Reach 8 has a) plenty of wood in the channel and good floodplain access with b) a mud-filled side channel adjacent to the active channel for half the reach.*

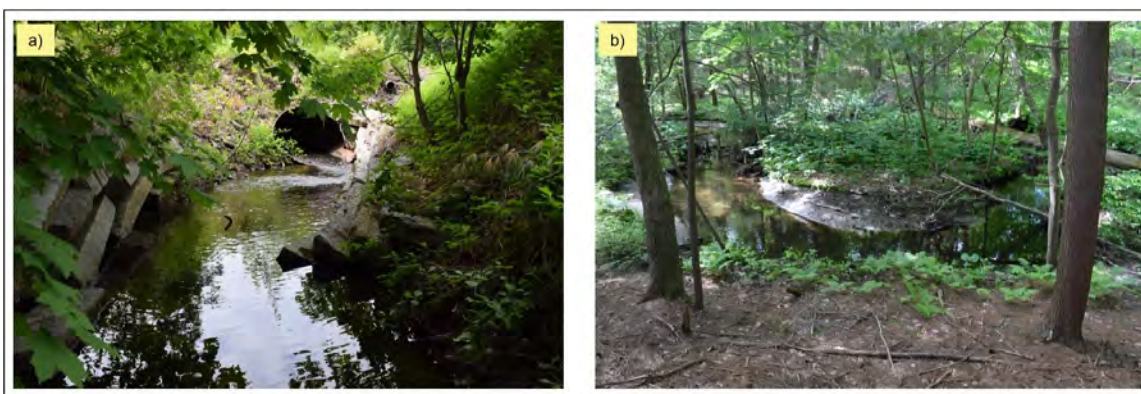
Figure 11. Reach 9 is a) narrowly confined and undermining granite blocks on the bank at the outlet of the Maine St. culvert but b) has a sinuous planform with abundant wood in the channel downstream.

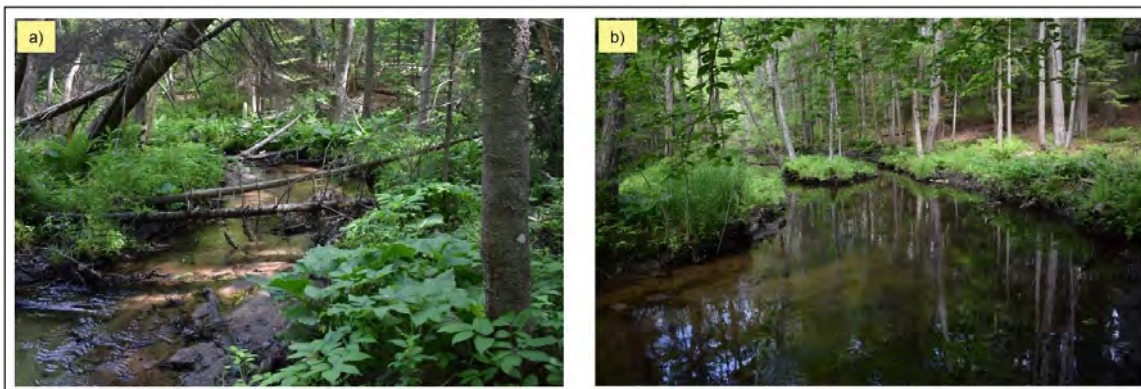
Figure 12. Reach 12 has a) a meandering planform upstream but is b) impounded further downstream.

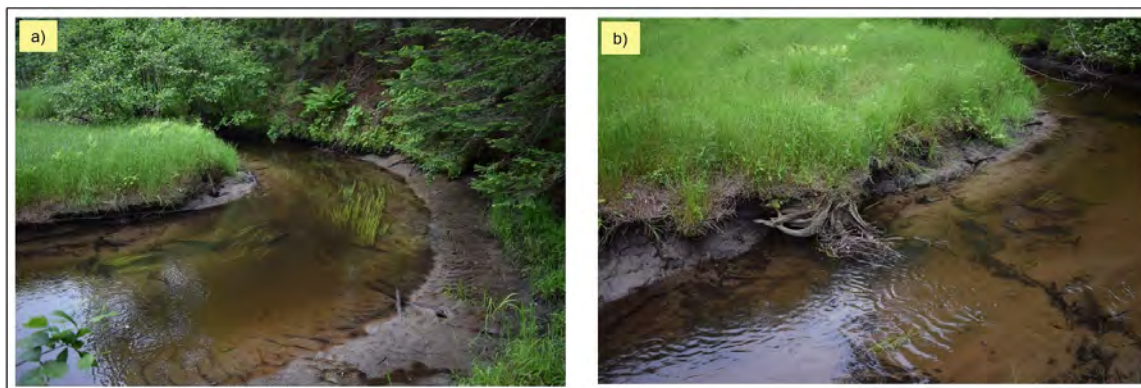
Figure 15. The sinuous Reach 13 has a) limited wood in the channel with minor bank erosion where encountering the valley sides and b) buried rooted stumps indicating 1 foot of deposition on the floodplain.

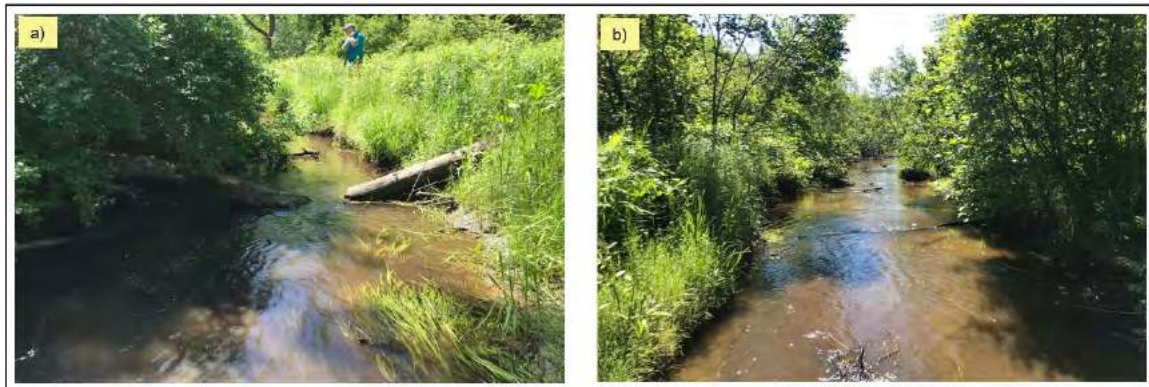
Figure 16. Reach 15 has a) relatively high banks and b) limited wood in the channel.

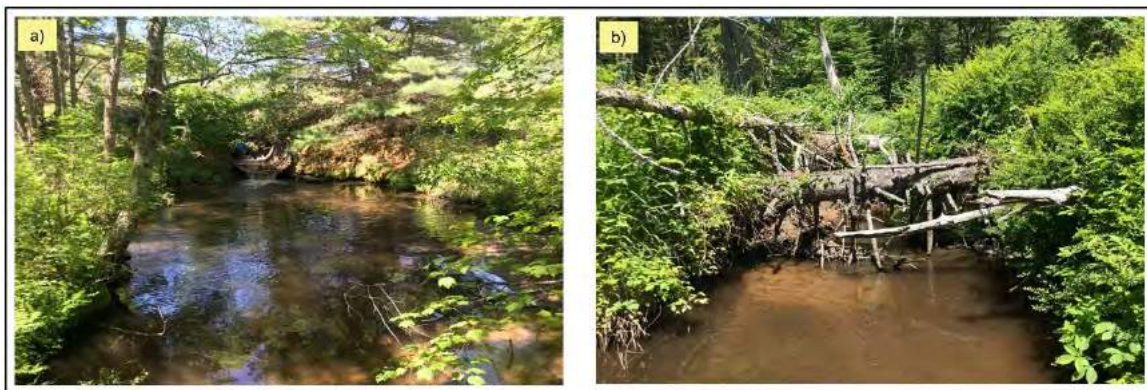
Figure 17. Reach 16 has a) experienced scour downstream of the perched culvert under Eagle Drive and b) considerable wood in the channel where the floodplain is well forested.

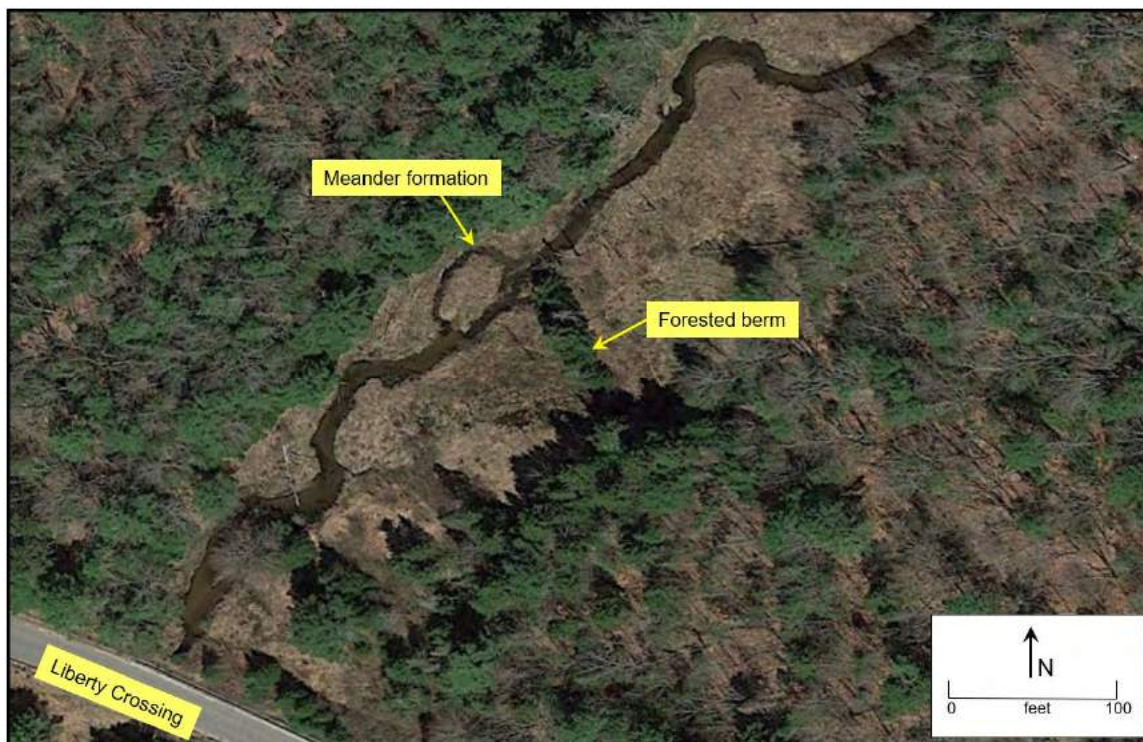
Figure 18. Google Earth image of the downstream end of Reach 17 highlighting the forested berm blocking the floodplain and the associated meander formation downstream.

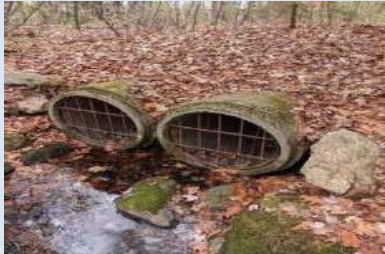
2	Thornton Oaks Trail Network	6' / 36"	Corrugated Metal Pipe  Round	Pipe condition = poor, undersized rusted Inlet condition = poor, restrictive to flow Outlet condition = poor, deflected	1) Remove culverts, restore channel 2) Replace with footbridge	1) Local permitting 2) Private landowner coordination	Low with landowner labor \$4 - 5K

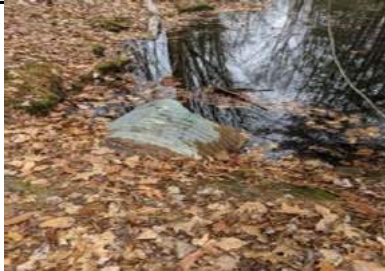
3	Thornton Oaks, Mathews Drive	Twin 35' / 48"	Reinforced Concrete Pipe / Round	Pipe condition = good Inlet condition = good, slightly undersized Outlet condition = good, minimal scour	None	Not applicable	None at this time

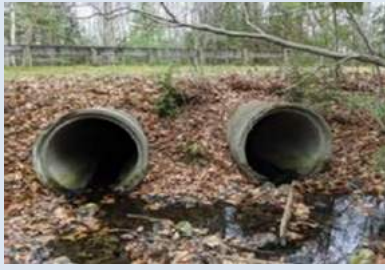
4	Baribeau Drive Crossing Flood Control	72' / 30"	Corrugated Metal Pipe Round	Pipe condition = good Inlet condition = fair Outlet condition = poor, obstructions present	1) Remove culvert along with Culvert 5, 2) Restore channel, 3) Replace with open bottom culvert	1) Federal, State permitting, 2) Hydrologic and Hydraulic (H&H) Model needed	High \$175 - 200K

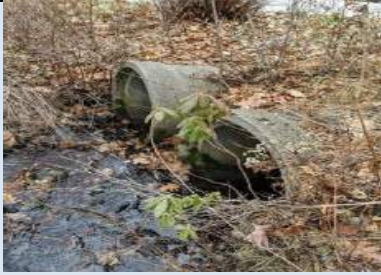
6	Baribeau Drive Southern Tributary Crossing	Two 35' / 18"	Reinforced Concrete Pipe / Round	Pipe condition = good Inlet condition = fair, some obstructions Outlet condition = poor, obstructed flow	1) Remove vegetation at inlet & outlet 2) Add riprap armor as needed	1) None	Low with Town labor \$1,000 - 1,500K

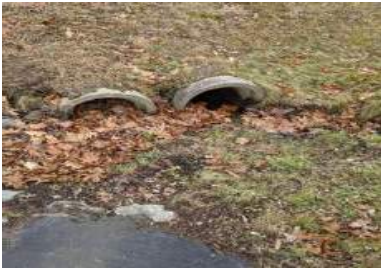
7	Mid Coast Regional Health Property - Southern Tributary	69' / 24"	Corrugated Metal Pipe / Round	Pipe condition = poor, deflected Inlet condition = fair, concrete wingwall Outlet condition = fair, riprap apron	None	Not Applicable	Not Applicable

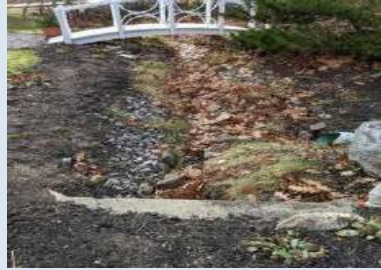
8	Mid Coast Senior Health Grounds	66' / 15"	Reinforced Concrete Pipe / Round	Pipe condition = good Inlet condition = armored, limited flow Outlet condition = armored	none	Not Applicable	Not Applicable

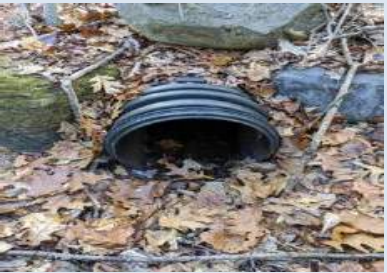
10	Barrows Street Crossing	Twin 31' / 24" & 48"	Corrugated Metal Pipes / Round	Pipe condition = poor, rusted bottoms Inlet condition = poor, restrictive to flow Outlet condition = poor with scouring	1) Remove undersized culverts, restore channel 2) Replace with larger opening	1) Federal, State permitting, 2) Hydrologic and Hydraulic (H&H) Model needed	Moderate with Town labor \$65 - 80K

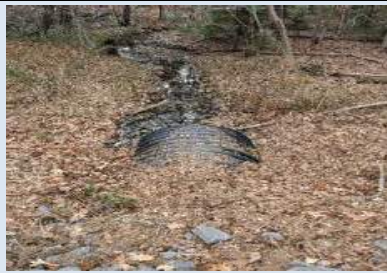
14	MacMillan Drive Crossing	Twin 31' / 24" & 48"	Corrugated Metal Pipe Round	Pipe condition = poor, undersized rusted Inlet condition = fair, restrictive to flow Outlet condition = fair	1) Remove culverts, restore channel 2) Replace with open bottom culvert	1) Federal, State permitting, 2) Hydrologic and Hydraulic (H&H) Model needed	Moderate with Town labor \$75 - 100K

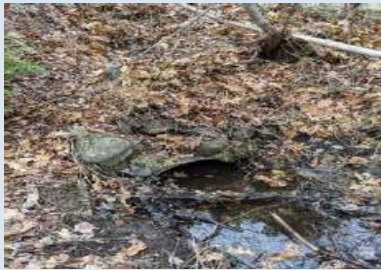
16	Maine Street Crossing	27' / 84"	Corrugated Metal Pipe / Elliptical	Pipe condition = fair, undersized Inlet condition = fair, restrictive to flow Outlet condition = fair, failing cribstone	1) Remove culverts, restore channel 2) Replace with open bottom culvert	1) Federal, State permitting, 2) Hydrologic and Hydraulic (H&H) Model needed	High \$200 - 225K

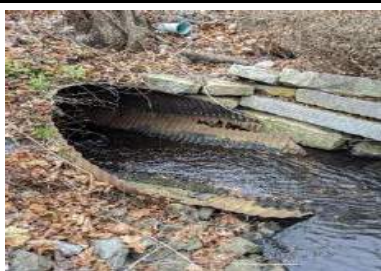
17	Meadowbrook Road Crossing	40' / 48"	Corrugated Metal Pipe Round	Pipe condition = fair, undersized Inlet condition = poor, restrictive to flow with ponding Outlet condition = fair, deflected	1) Remove culvert, restore channel 2) Upsize culvert	1) Federal, State permitting, 2) Hydrologic and Hydraulic (H&H) Model needed	High \$100 - 125K

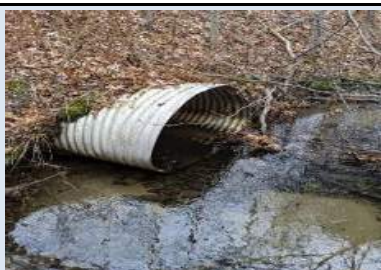
18	Sparwell Lane Tributary Crossing	29' / 30"	Corrugated Metal Pipe Round	Pipe condition = poor, undersized rusted Inlet condition = poor, restrictive to flow Outlet condition = poor, heavy sediment	1) Upsize culvert 2) Rebuild road	1) Federal, State permitting, 2) Hydrologic and Hydraulic (H&H) Model needed	High \$100 - 125K

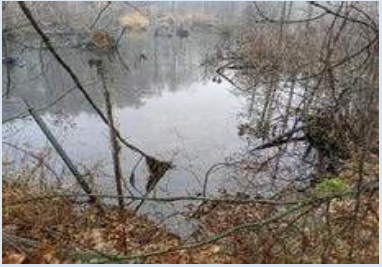
24	Merriconeag Road Crossing	24' / 72"x36"	Concrete Box Culvert Rectangular	Pipe condition = good, drainage fair Inlet condition = good, no restriction Outlet condition = fair, perched outlet	1) Add riprap at outlet	1) Town labor	Low with Town labor \$500

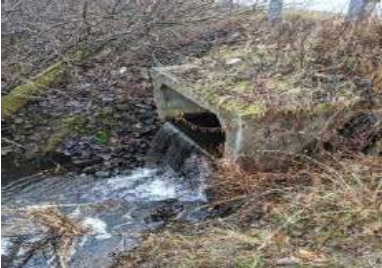
25	Merriconeag Road Crossing (2)	10' / multiple pipes	PE N-12 Pipe Round	Pipe condition = good, undersized Inlet condition = poor, restrictive to flow Outlet condition = poor, blockage	1) Remove culverts, restore channel 2) Upsize culvert	1) Town labor	Low with Town labor \$10 - 12K

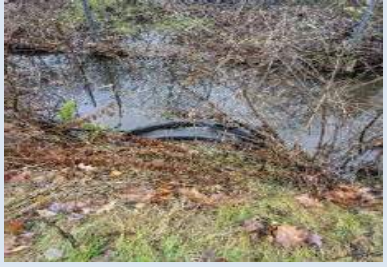
29	Eagle Drive Crossing	96"	CMP Round	Pipe condition = fair Inlet condition = fair, some obstruction Outlet condition = hanging	Remove vegetation at trash racks	Routine maintenance	Low - \$500

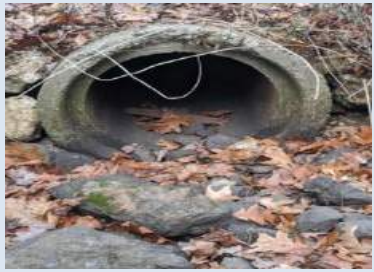
12	At Harpswell Road Crossing	24	Corrugated Metal Pipe / Round	<ul style="list-style-type: none"> <li>• Significant sediment at inlet</li> <li>• Pipe structure in fair shape</li> <li>• Restricted flow due to sediment</li> </ul>	Clear sediment at inlet and outlet	Town labor	Low \$500

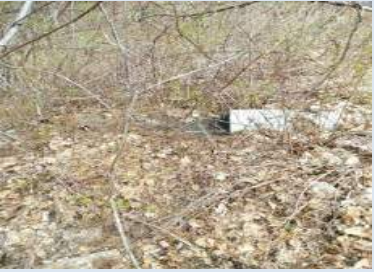
17	Off Sparwell Lane	15	Clay Pipe Round	<ul style="list-style-type: none"> <li>• Adequately sized</li> <li>• Pipe structure in bad shape</li> <li>• Pipe section missing and erosion at outlet</li> </ul>	Retrofit outlet with new section and outlet protection	Town permitting and labor	Moderate \$10 - 12K with Town Labor

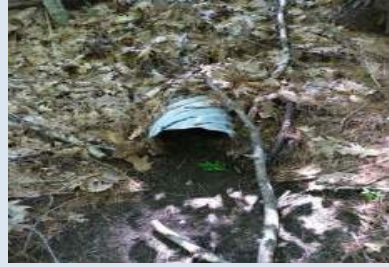
19	Off Breckam Road	12	Clay Pipe / Round	<ul style="list-style-type: none"> <li>• Adequately sized</li> <li>• Pipe structure in poor shape</li> <li>• Submerged at outlet, heavy vegetation</li> </ul>	Replace outfall pipe and provide outlet protection	Town permitting and labor/Private land	Moderate \$10,000 - 15,000 with Town Labor

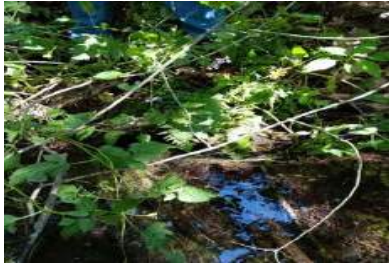
20	Off MacMillan Drive	18	Corrugated Metal Pipe & Concrete / 1/2 circle	<ul style="list-style-type: none"> <li>• Concrete foundation failing</li> <li>• Sediment at outlet and in stream</li> </ul>	Remove outfall and replace with road catch basin	Town permitting and labor	Moderate \$12,500 - 17,500 with Town Labor

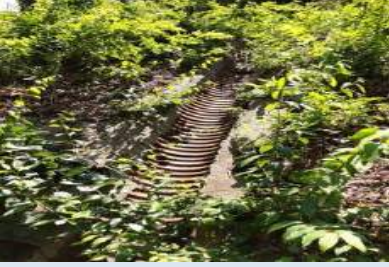
21	Off Magean Street	15	Corrugated Metal Pipe / Round	<ul style="list-style-type: none"> <li>• Pipe rusted and failing</li> <li>• Outlet structure needs to be replaced</li> </ul>	Replace outfall pipe and add new structure	Town permitting and labor/Private land	Moderate \$15,000 - 20,000 with Town Labor
