Chapter 4: Trout Brook in Cape Elizabeth and South Portland

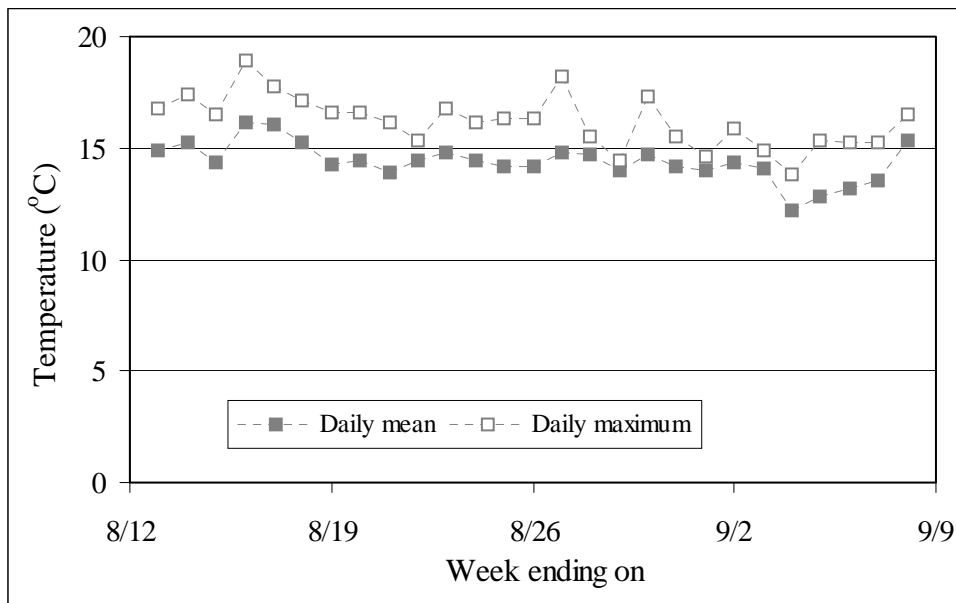
Fig. 2. Continuous water temperature at downstream station in 1997

Model results indicated that in 1997 and 2000, macroinvertebrates at the downstream station did not meet Class C aquatic life criteria with the dominant organisms consisting of tolerant crustaceans (predominantly amphipods, few isopods) and few chironomids (midge larvae; Table 1). In 1999, macroinvertebrates met Class C aquatic life criteria as amphipods made up a smaller proportion of the sample and some Ephemeroptera (mayflies) were found. In all years, an intermediate number of organisms was present (486 – 628, Table 1). A good general indicator of the quality of a macroinvertebrate community is the percentage of non-insects in a sample, as this increases with decreasing water quality. The percentage of non-insects at the downstream station was very high in all sampling years, namely 94, 76 and 98 % in 1997, 1999, and 2000, respectively. Water quality data collected at this station indicated adequate dissolved oxygen concentrations (7.1, 8.7, and 9.2 mg/L), high conductivity levels (792, 832 and 695 $\mu\text{S}/\text{cm}$), and low water temperatures (13.0, 15.0, and 14.6 °C). Continuous water temperature data collected August 13 to September 8, 1997 (measurements taken every 5 min), and August 1 to 30, 2000 (measurements taken every 15 min) showed that daily mean temperatures were low, i.e., favorable for healthy macroinvertebrate communities. Daily maximum temperatures were slightly higher but still below 20 °C (Figs. 2 and 3). Water chemistry sampling in 2000 (Table 2) showed that Total Nitrogen was the only parameter to exceed available Water Quality Criteria.

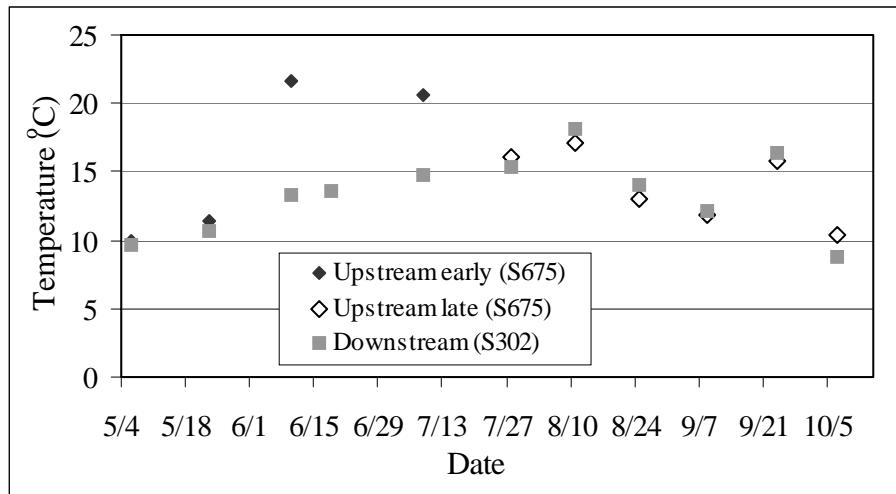
Instantaneous water temperature was quite variable at all stations, ranging from 8.8 - 18.2 $^{\circ}\text{C}$ at the downstream station (gray squares in Fig. 6), from 10.0 - 21.6 $^{\circ}\text{C}$ at the early upstream station (black diamonds in Fig. 6), and from 10.4 - 17.1 $^{\circ}\text{C}$ at the late upstream station (open diamonds in Fig. 6). The single temperature measurement taken at the wetland station on June 12 was 20.7 $^{\circ}\text{C}$. Measurements taken on May 8, 2004, at the downstream and late upstream stations were 13.6 and 13.0 $^{\circ}\text{C}$, respectively. On July 6, 2004, water temperature was at 16.0 $^{\circ}\text{C}$ at the downstream station.

Fig. 6. Instantaneous water temperature

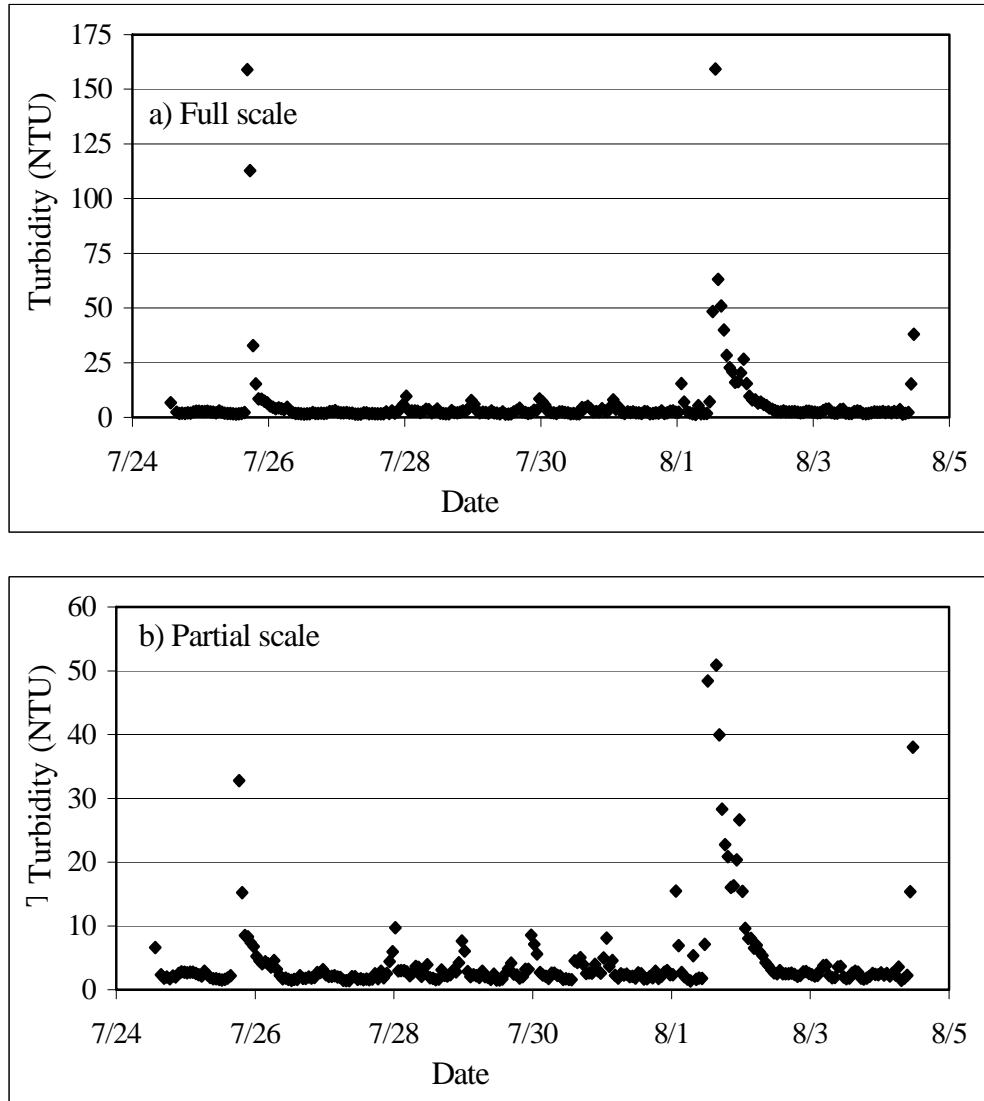
Mean hourly turbidity calculated from records collected every 10 min showed large variation, ranging from 1 - 657 NTU (Fig. 11 a and b; same data with different scales). The maximum instantaneous value measured was 1,787 NTU. The majority of the time, turbidity ranged from 1 - 10 NTU (Fig. 11 b), and the EPA-recommended criterion of 3.04 NTU (EPA 2000b) was exceeded 30 % of the time. The two spikes recorded on July 25 and August 1 (Fig. 11 a) occurred during rain events and are likely related to the turbulence created by rainwater and storm runoff entering the stream causing sediment to be stirred up (App. G, Fig. 6), and likely also bringing sediment into the stream. Small spikes, i.e., those reaching ~10 NTU (Fig. 11 b), occurred on several days and were not associated with rain events; instead these small spikes showed a temporal pattern in that they always occurred around midnight¹.

¹ Data collected in 2004 suggest that these turbidity spikes may have been related to saltwater intrusions (see Discussion, Water Quality Monitoring, Saltwater Intrusions, below)

Fig. 11. Continuous turbidity at downstream station (7 days)

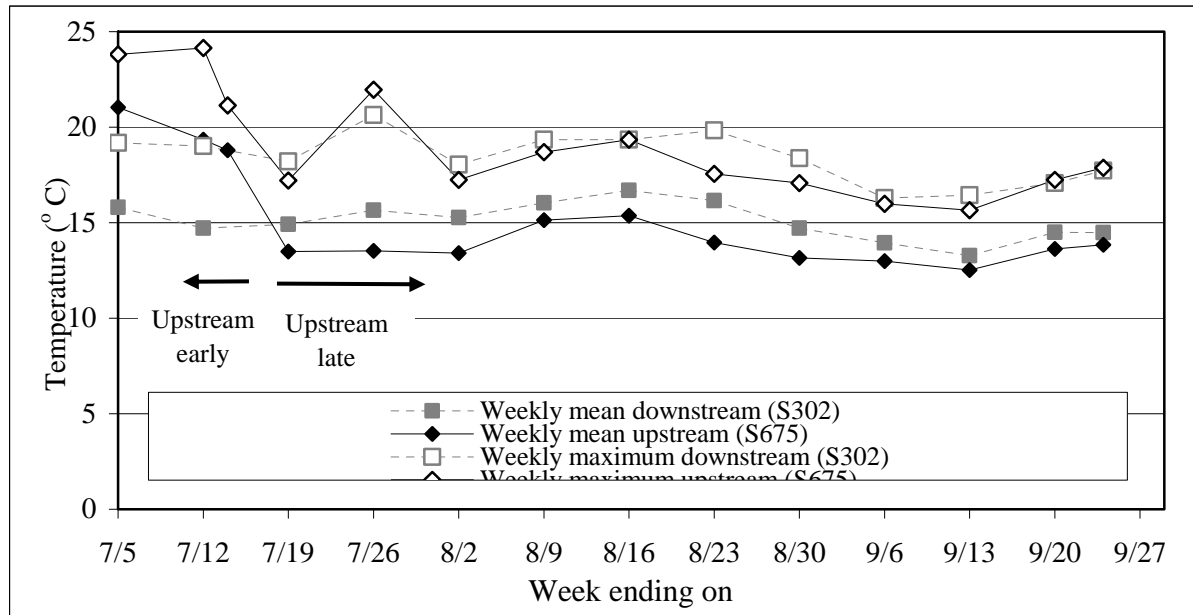
Continuous water temperature at the downstream station (squares and dashed lines in Fig. 12, measured at 20-min intervals) showed relatively cool and stable weekly mean temperatures between 13.3 and 16.7 °C, and warmer, more variable weekly maximum temperature between 16.3 and 20.6 °C. At the early upstream station (diamonds and solid lines in Fig. 12), the weekly mean temperature for the 11 days the temperature logger was in place at this station was quite high, around 20 °C, and the weekly maximum temperature was even higher, around 23 °C. At the late upstream station (diamonds and solid lines in Fig. 12), the weekly mean temperature was quite cool, between 12.5 and 15.4 °C, while the weekly maximum temperature was significantly higher, between 15.7 and 22.0 °C.

Fig. 12. Continuous water temperature (85 days)

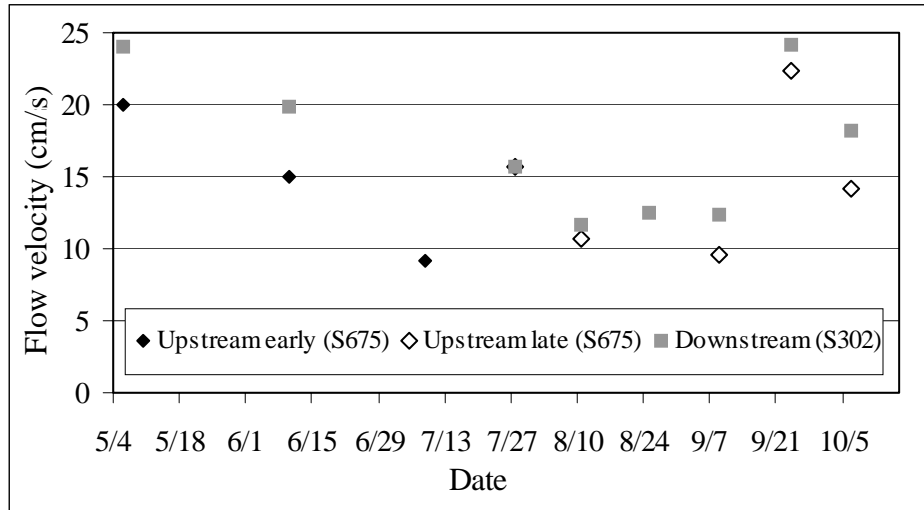
Instantaneous flow velocity was similar and quite variable at both stations (including visual estimates, which were reduced to 0.8 of observed surface flow to account for the lower velocity at mid-depth¹): downstream it ranged from 12 - 24 cm/s with a mean of 16 cm/s (gray squares in Fig. 13); at the early upstream station, flow was recorded at 15 and 9 cm/s on the two measurement dates, i.e., at a mean of 12 cm/s (black diamonds in Fig. 13); and at the late upstream station, it ranged from 10 - 22 cm/s with a mean of 14.5 cm/s (open diamonds in Fig. 13).

Fig. 13. Instantaneous flow velocity

Note that first data point at both stations is visual estimate.

The variable flow regime found at the downstream and most of the late upstream station (instantaneous flow velocity and thalweg velocity, Figs. 13 and 14) is a positive feature of these sections of the stream as it provides aquatic organisms with a wide variety of environments to occupy, thus increasing the potential for a diverse biological community. Furthermore, a swift flow regime reduces siltation, and promotes re-aeration of the stream with dissolved oxygen.

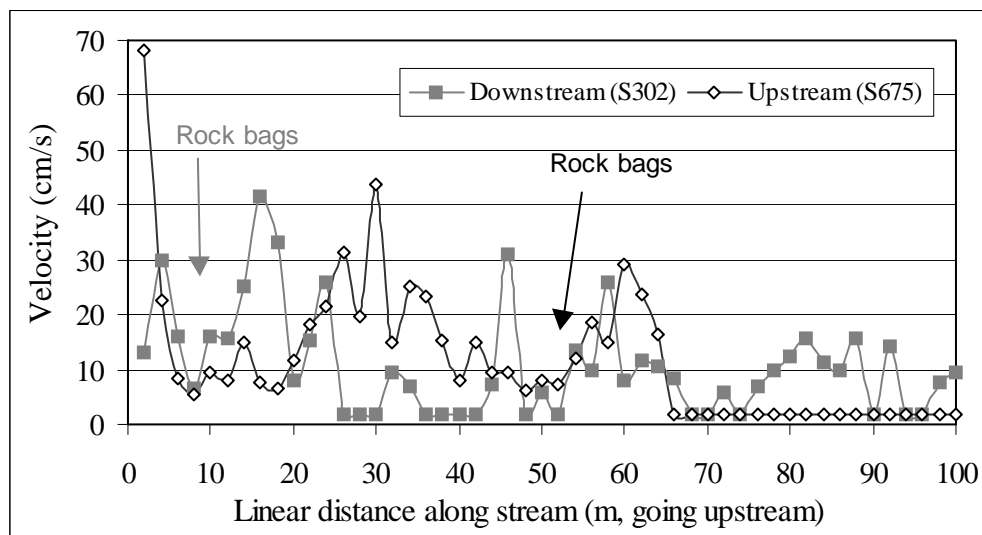
The thalweg velocity at and above the downstream station was highly variable, with velocities ranging from approximately 1 - 42 cm/s with a mean of 11 cm/s (gray squares in Fig. 14). At the late upstream station, a similarly variable flow regime with velocities ranging from approximately 1 - 68 cm/s and a mean of 12 cm/s was measured in the lower ~65 m of the 100 m stretch, but no flow was registered above this point, where the stream was dammed up by a small cobble dam (open diamonds in Fig. 14).

Fig. 14. Thalweg velocity

Flow velocity in the upper ~ 35 m of the section around the late upstream station (Fig. 14) was very low, which is likely in part a natural condition. Above this section, near the early upstream station, the stream in the summer lacks a distinct channel but rather consists of a network of small rivulets slowly draining into a marshy area. At the outflow of this area (at the ~ 95 m mark in Fig. 15), a spring-fed channel joins the stream and helps re-establish a defined channel leading to the late upstream station where a small ($\sim 12''$ tall) cobble dam creates a pond-like situation before a distinct channel with good flow is re-established (at the ~ 65 m mark in Fig. 15). Above the dam, the stream bottom consists of fine sediment, indicating a significant siltation problem. Removal of the dam likely would improve flow patterns and reduce siltation for an additional ~ 25 m, leaving only the uppermost ~ 10 m within the marshy area to be less favorable habitat for macroinvertebrates in terms of flow velocity.

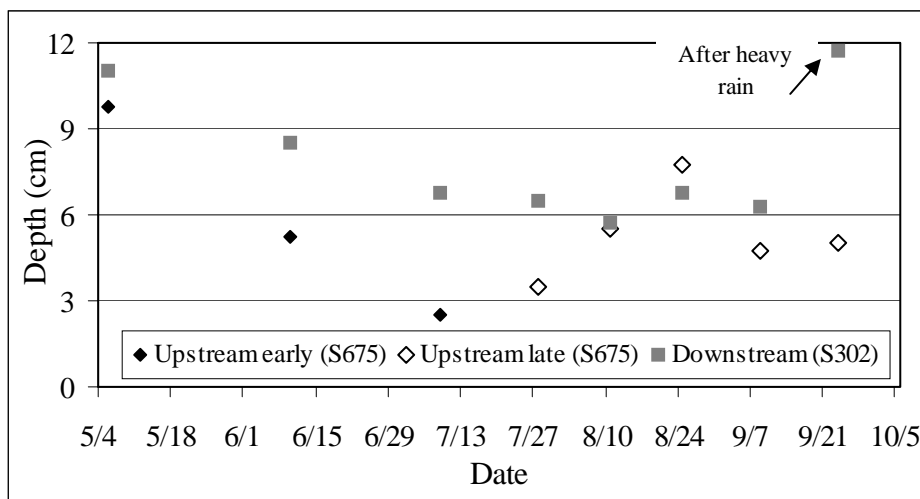
Mean stream depth was quite variable throughout the sampling period at all stations. At the downstream station, it ranged from 5.8 - 11.8 cm with a mean of 7.8 cm (gray squares in Fig. 16). However, during the summer months, depth was quite stable at this station, between 5.8 and 6.8 cm. At the early upstream station, depth declined significantly, from 9.8 to 2.5 cm (black diamonds in Fig. 16). At the late upstream station, depth was variable, ranging from 3.5 - 7.8 cm with a mean of 5.6 cm (open diamonds in Fig. 16).

Fig. 16. Mean stream depth

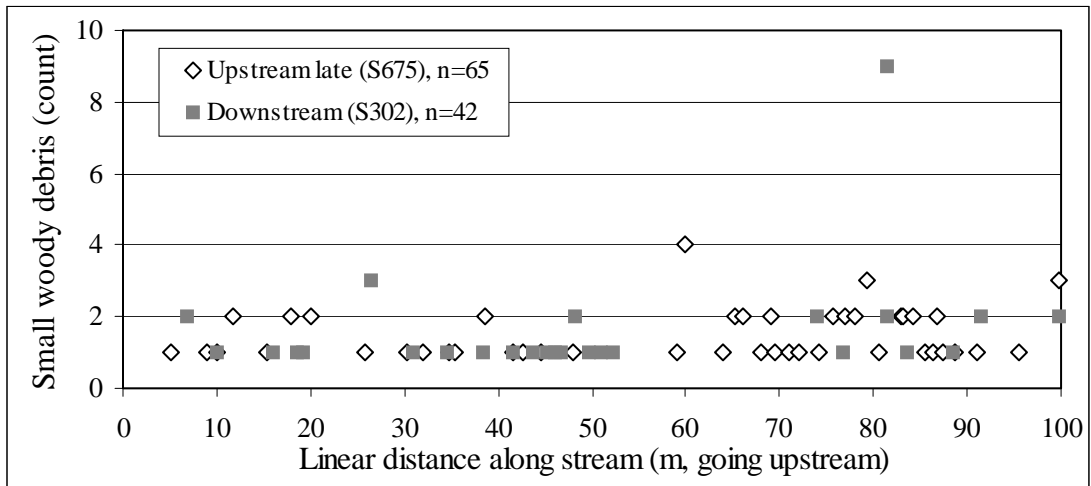
Fig. 18. Distribution of small woody debris (2-5 cm diameter, >100 cm length)

The abundance of small woody debris (SWD) at the late upstream station reflects the large number of small trees growing up in that area, especially within the ponded up section above the cobble dam (above ~60 m in Fig. 18). If small trees are excluded, 50 pieces of SWD were found, about the same number as at the downstream station. Small woody debris is less valuable as woody debris than larger pieces because it is exported more readily (unless it is in the form of a live tree), and provides fewer possibilities for shelter, colonization, or trapping of materials.
