# Mare Brook Watershed Management Plan

2022-2032

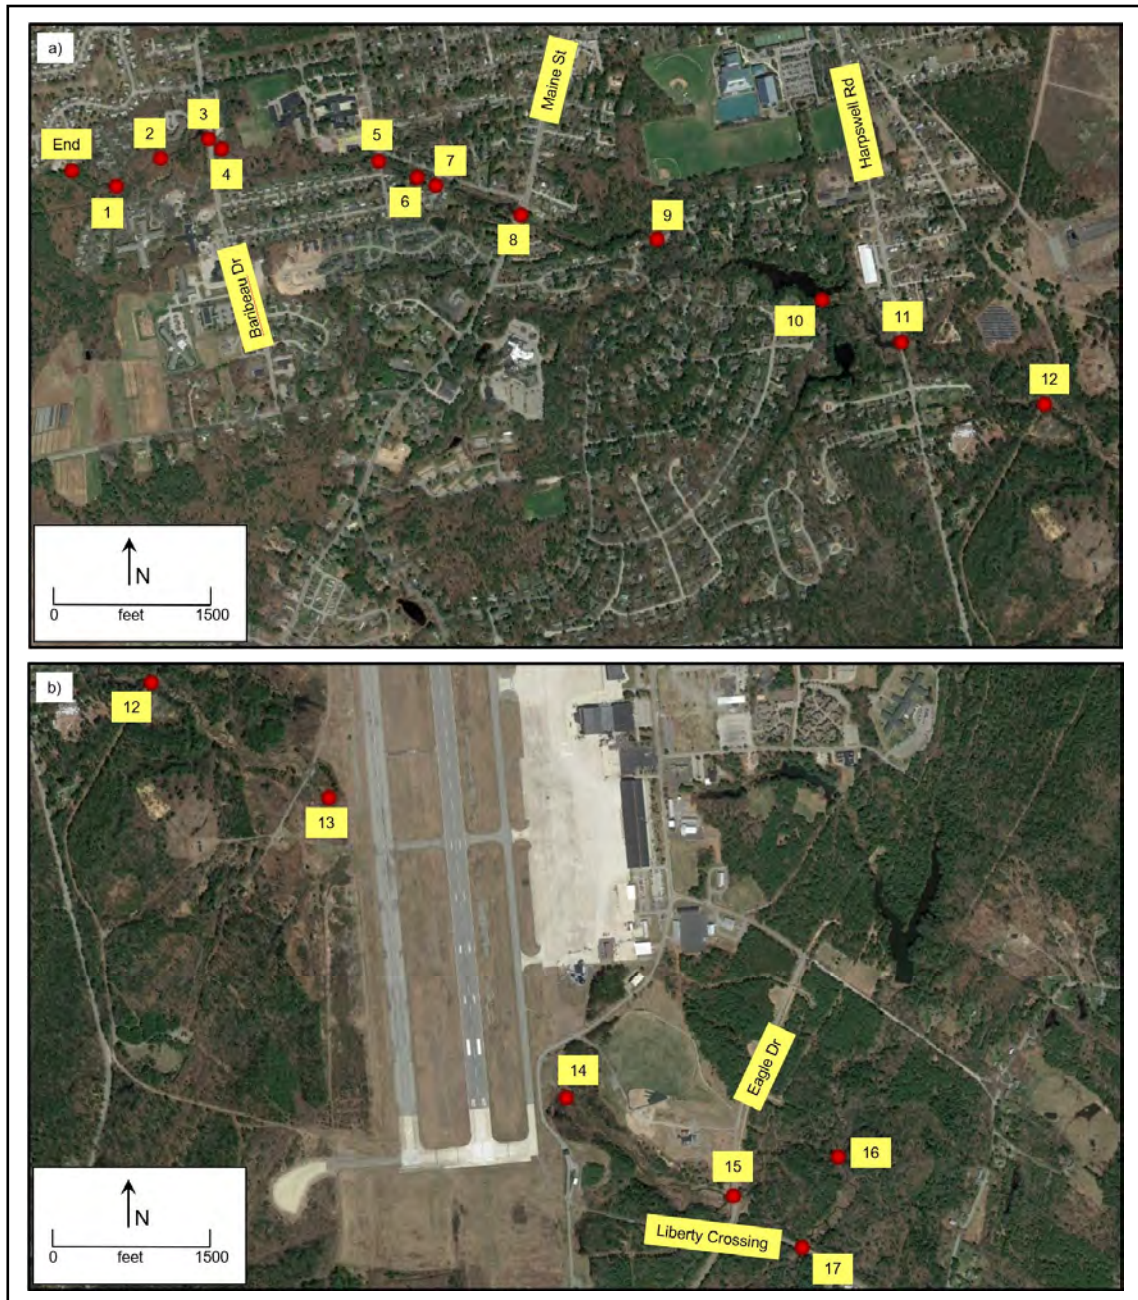
Figure 2. Location of reach breaks on Mare Brook shown as red dots a) upstream and b) downstream of the perimeter road. Reach number placed at downstream end of reach.

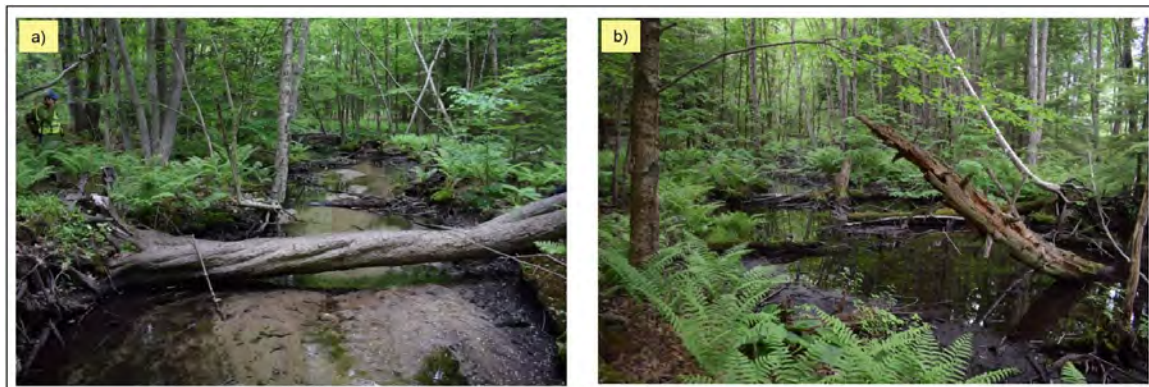
Much of Reach 3 may be backwatered due to the undersized culverts passing under Baribeau Drive. The channel is wide (more similar to Reach 1 than Reach 2 just upstream) with abundant silt/sand bars around which the flow is diverted, leading to the undermining and collapse of trees into the channel (Figure 5a). The channel banks are very low and become increasingly ill-defined approaching Baribeau Drive where flow becomes more obviously ponded (Figure 5b). Due to the ponding at the upstream side of the Baribeau Drive, the channel, if it can even be so characterized, is spread out over a wide area with at least 4 widely spaced small culverts (2 are side by side) passing under the road.

*Figure 5. Reach 3 is influenced by the downstream culvert at Baribeau Dr. with a) trees undermined by flow diversion around deposited sediment and b) low banks and ponding further downstream.*

Flow velocities are likely reduced throughout the reach due to the undersized culverts at Baribeau Drive, thus severely altering the morphological character and stream habitat with an increasing impact further downstream in the reach. Restoration of fluvial processes throughout the reach can only be achieved by replacing and consolidating the culverts into a single properly sized crossing at a well-defined channel that would naturally be present in the absence of the road-induced ponding.

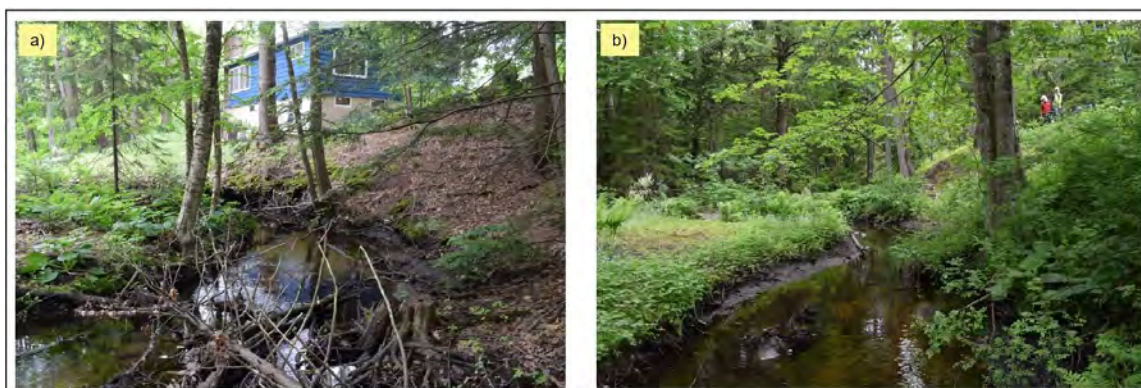
The channel in Reach 7 is meandering with good connection to its narrow partially forested floodplain (Figure 9a). The absence of a fully forested floodplain is likely related to the presence of homes adjacent to the channel with the property of one home experiencing minor bank erosion at the apex of a meander bend (Figure 9a). While some wood is present in the channel, the absence of wood through much of the reach may also

be related to the lack of a fully forested floodplain (Figure 9b). Much of the channel bed is composed of firm sand, although large cobbles occur in one area where the channel flows along the higher banks below Richards Drive. The morphology of the channel is not greatly altered by the presence of the culvert passing under MacMillan Drive.

Figure 9. Reach 7 has a meandering channel causing erosion on the outside bends with b) the limited wood in the channel likely related to the absence of a well-forested floodplain.

The good channel morphology in Reach 7 (e.g., meandering planform, access to floodplain) indicates significant restoration is unnecessary. However, the limited amount of wood in the channel could be addressed with instream wood additions that would need to be anchored in place given the adjacent homes, roads, and MacMillan Drive culvert. The wood could be used to form habitat structures and for a bioengineering project to stabilize the erosion along one residential property (Figure 9a). Long-term sustainability of instream wood could be enhanced by riparian plantings to restore the forested floodplain.

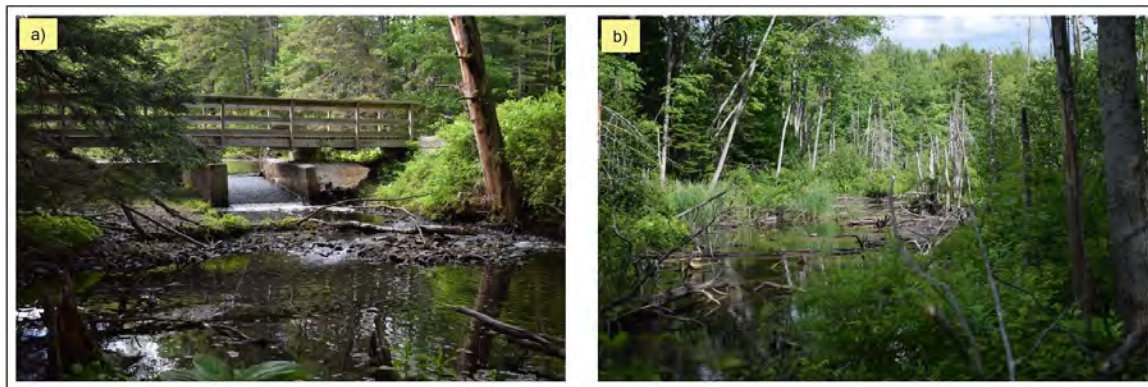
Immediately downstream of the Coffin Pond Dam, the channel has an armored rocky substrate (Figure 13a) that quickly transitions into a shallow channel infilled with a soft-fine-grained substrate due to backwatering upstream of the undersized culvert passing under Harpswell Road. Further evidence of the backwatering is seen in the form of numerous dead standing trees present on the wide floodplain (Figure 13b).

*Figure 13. Reach 11 is a) armored on the bed of the channel downstream of the Coffin Pond Dam and b) impounded downstream by the Harpswell Road culvert.*

Restoration of fluvial processes in Reach 11 will depend on the resizing of the Harpswell Road culvert, a costly project that will likely occur only when the functional life of the existing culvert nears its end.

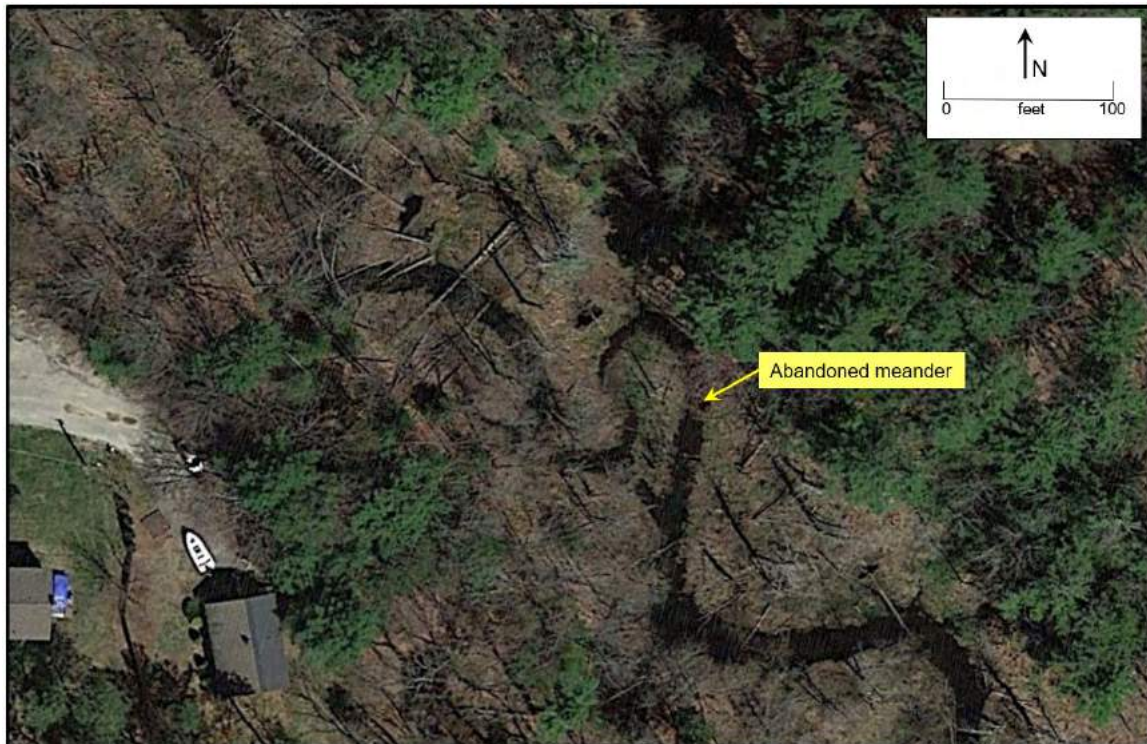
A deep scour pool is present at the outlet of the slightly perched Harpswell Road culvert with the majority of the flow directed to a channel to the left (looking downstream) with a minor portion flowing straight. The upper portion of the reach is covered with a dense growth of alders and becomes more forested with tall mature trees further downstream. The channel is highly sinuous with a high amplitude cutoff meander present (Figure 14 – aerial photo), suggesting the channel is dynamic and subject to shifting across the floodplain. This dynamic nature is likely enhanced by the abundant wood in the channel, including a tree that is blocking 40 feet of the channel after falling in alignment with and directly into the channel. Numerous sand bars are present that has reduced the depth of the channel, although deeper pools are formed around wood in the channel. The lower half of the reach is backwatered behind the culvert passing under the perimeter road and likely enhances the sediment deposition and shallow nature of the channel.

Figure 14. A large abandoned meander and abundant wood in the channel suggest Reach 12 is dynamic.

The upper half of the reach with good wood loading and sinuous planform does not require restoration. Similar fluvial processes could be enhanced in the lower half of the reach by resizing the culvert passing under the perimeter road.

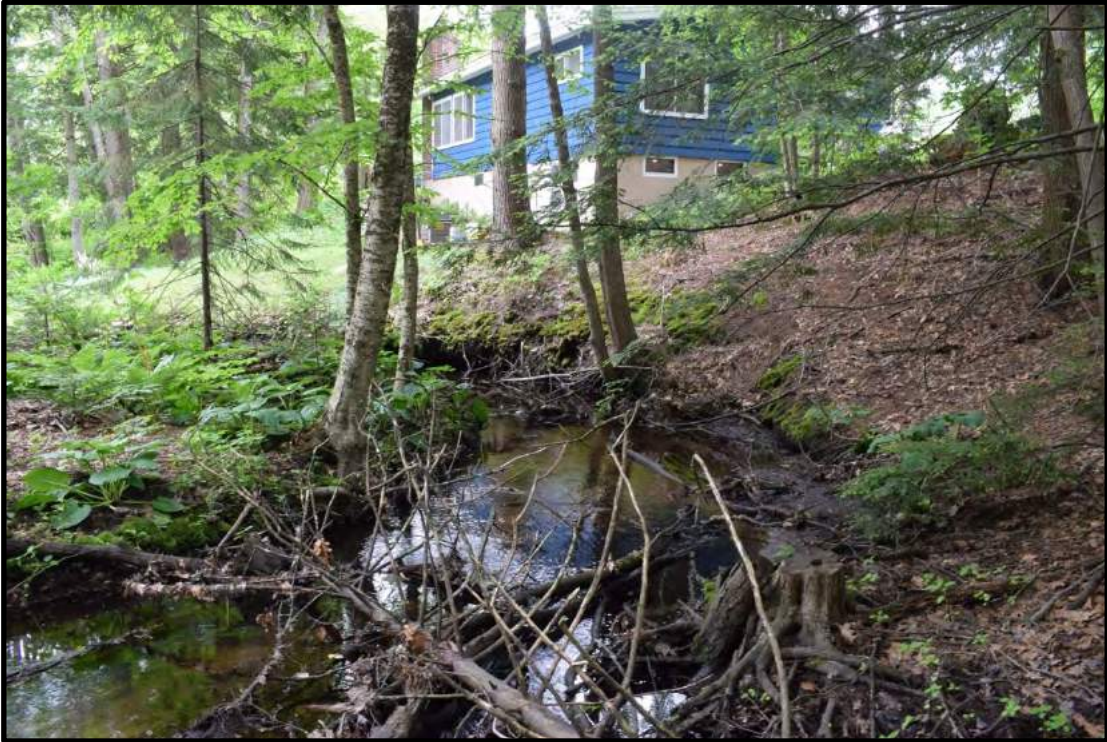
Appendix 3. Photo 11 – Reach 7: Downstream view from right bank of erosion at apex of meander near residential home.

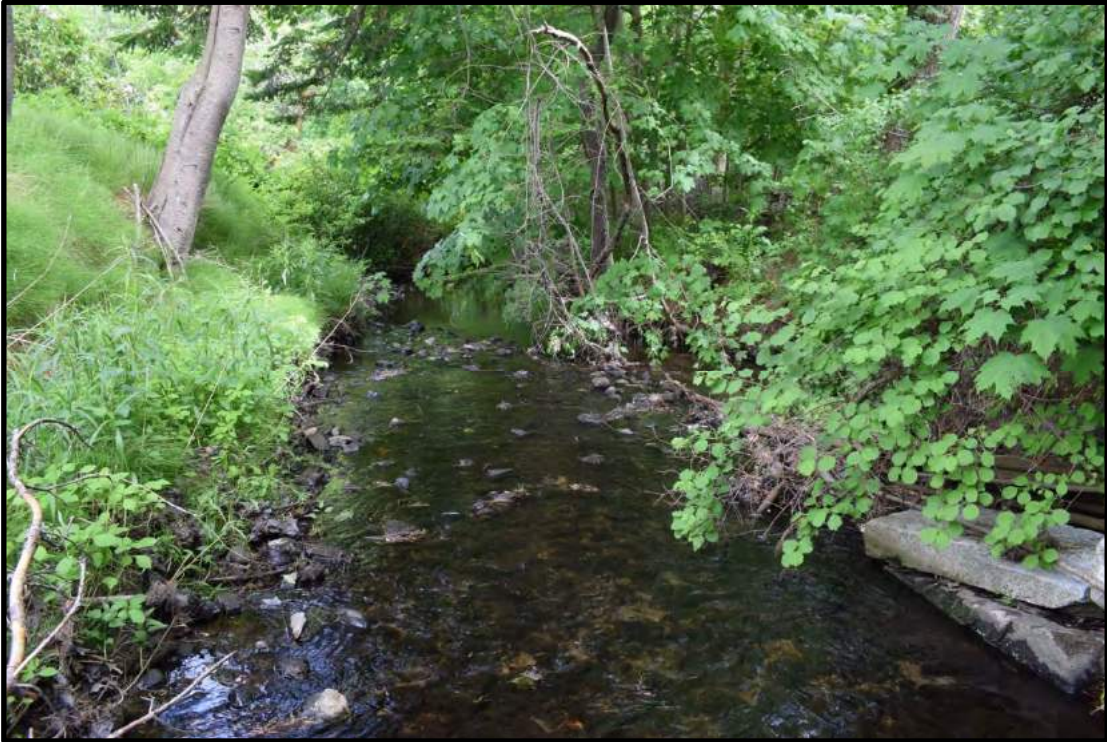
Appendix 3. Photo 15 – Reach 9: Upstream view of granite blocks and Maine Street culvert outlet.

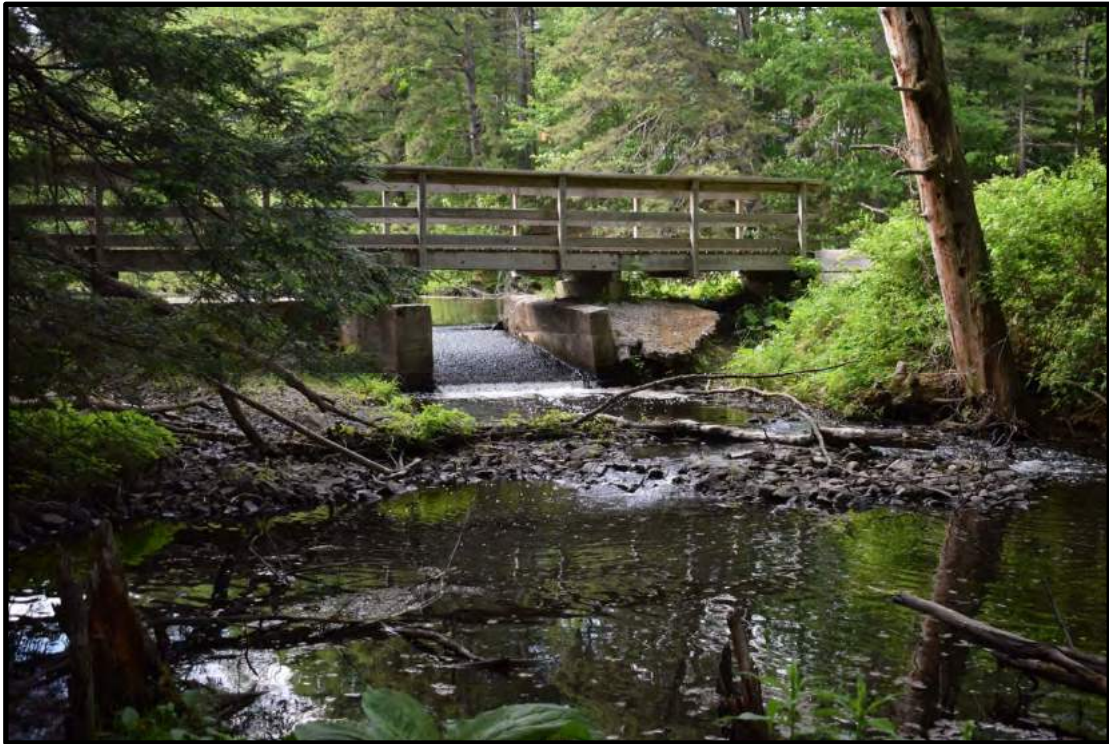
Appendix 3. Photo 16 – Reach 9: Downstream view from downstream end of granite blocks.

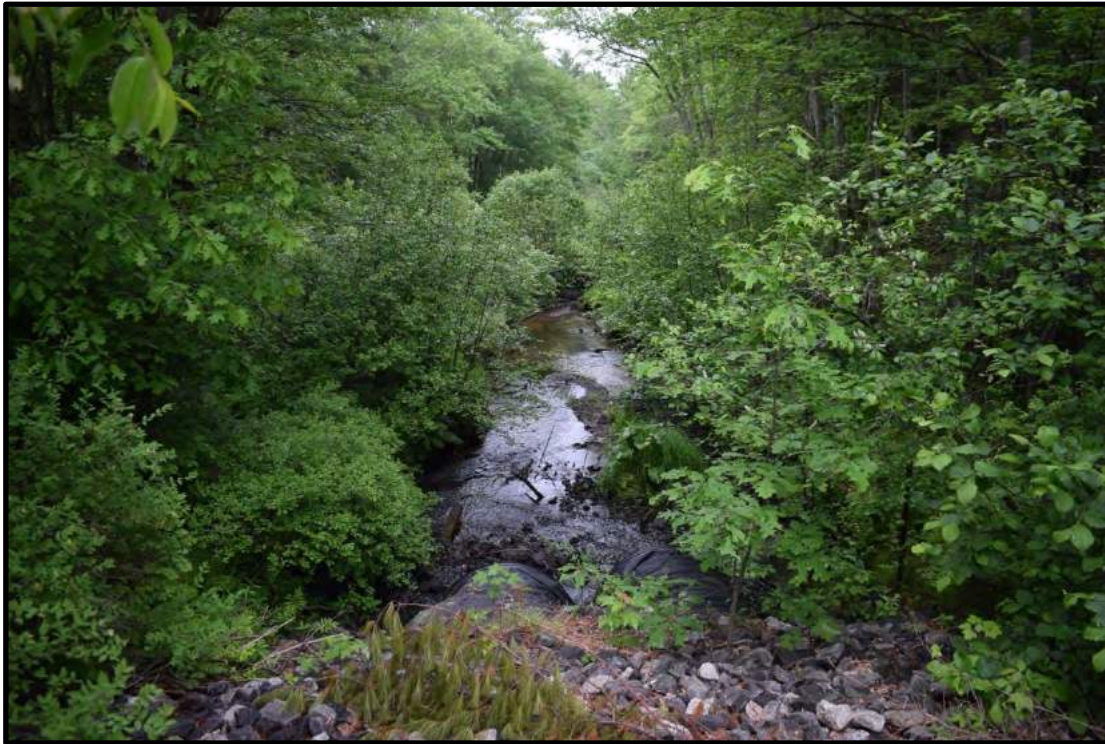
Appendix 3. Photo 17 – Reach 11: Upstream view from right bank of Coffin Pond Dam.

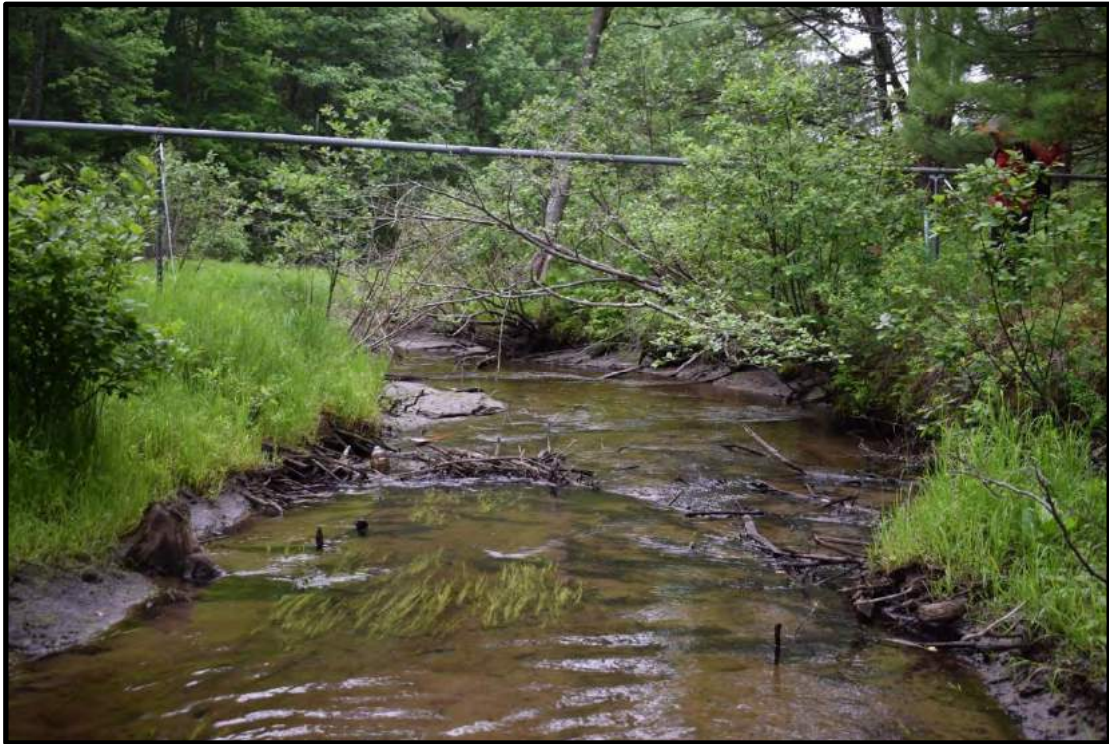
Appendix 3. Photo 18 – Reach 13: Downstream view from perimeter road.

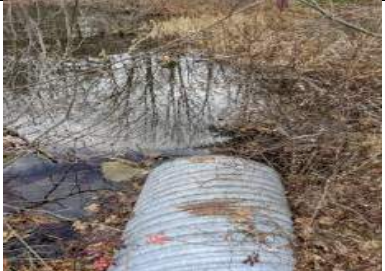
4	Baribeau Drive Crossing Flood Control	72' / 30"	Corrugated Metal Pipe Round	Pipe condition = good Inlet condition = fair Outlet condition = poor, obstructions present	1) Remove culvert along with Culvert 5, 2) Restore channel, 3) Replace with open bottom culvert	1) Federal, State permitting, 2) Hydrologic and Hydraulic (H&H) Model needed	High \$175 - 200K

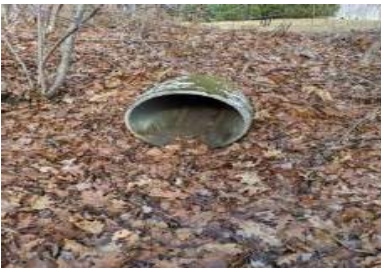
8	Mid Coast Senior Health Grounds	66' / 15"	Reinforced Concrete Pipe / Round	Pipe condition = good Inlet condition = armored, limited flow Outlet condition = armored	none	Not Applicable	Not Applicable

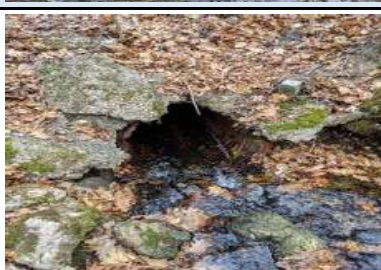
18	Sparwell Lane Tributary Crossing	29' / 30"	Corrugated Metal Pipe Round	Pipe condition = poor, undersized rusted Inlet condition = poor, restrictive to flow Outlet condition = poor, heavy sediment	1) Upsize culvert 2) Rebuild road	1) Federal, State permitting, 2) Hydrologic and Hydraulic (H&H) Model needed	High \$100 - 125K

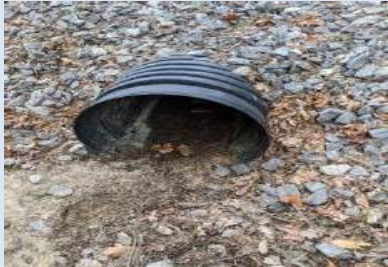
Culvert #	Location	Length (ft) / Size (in)	Material/Shape	Condition	Recommendation	Requirements	Estimated Cost <sup>†</sup>	Ground photo
19	Shulman Park Entrance Tributary Crossing	20' / 24"	PE N-12 Pipe / Round	Pipe condition = good, new install Inlet condition = good Outlet condition = good	None	Not applicable	None at this time

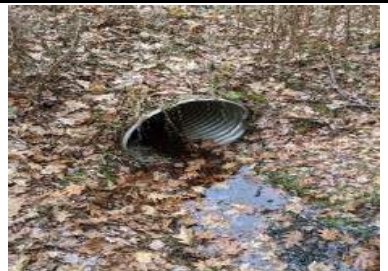
20	Alder Dive Tributary Crossing	24' / 36"	Corrugated Metal Pipe Round	Pipe condition = good Inlet condition = good, no flow restriction Outlet condition = good	None	Not applicable	None at this time

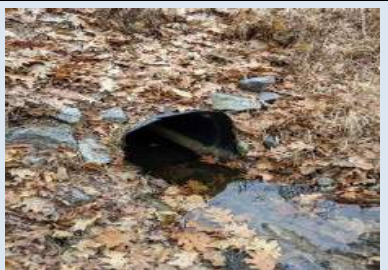
21	Parkview Hospital Circle - Tributary	33' / 24"	PE N-12 Pipe Round	Pipe condition = good Inlet condition = good, some damage Outlet condition = good	None	Not applicable	None at this time

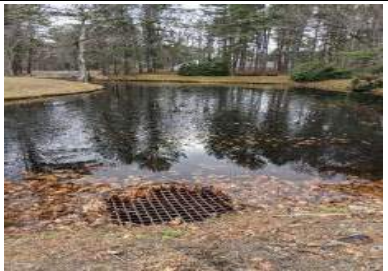
22	Parkview Hospital Circle 2 - Tributary	19' / 24"	Reinforced Concrete Pipe Round	Pipe condition = good Inlet condition = good Outlet condition = good, outlet control structure for pond	None	Not applicable	None at this time

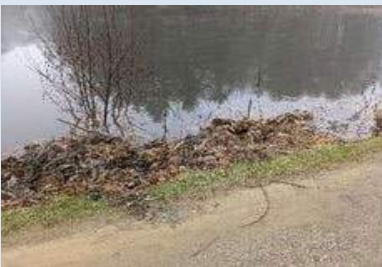
25	Merriconeag Road Crossing (2)	10' / multiple pipes	PE N-12 Pipe Round	Pipe condition = good, undersized Inlet condition = poor, restrictive to flow Outlet condition = poor, blockage	1) Remove culverts, restore channel 2) Upsize culvert	1) Town labor	Low with Town labor \$10 - 12K

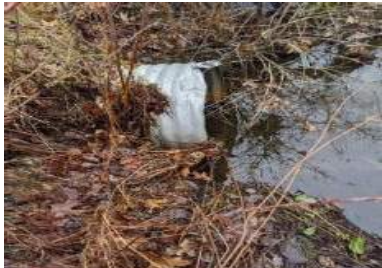
27	Puritan Road Tributary Crossing	23' / 24"	Corrugated Metal Pipe Round	Pipe condition = good Inlet condition = fair, vegetation removal Outlet condition = good	None	Not applicable	None at this time

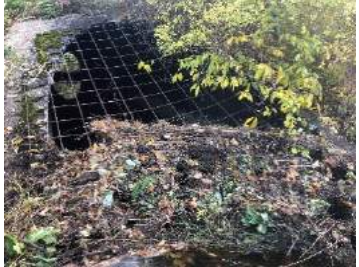
29	Eagle Drive Crossing	96"	CMP Round	Pipe condition = fair Inlet condition = fair, some obstruction Outlet condition = hanging	Remove vegetation at trash racks	Routine maintenance	Low - \$500

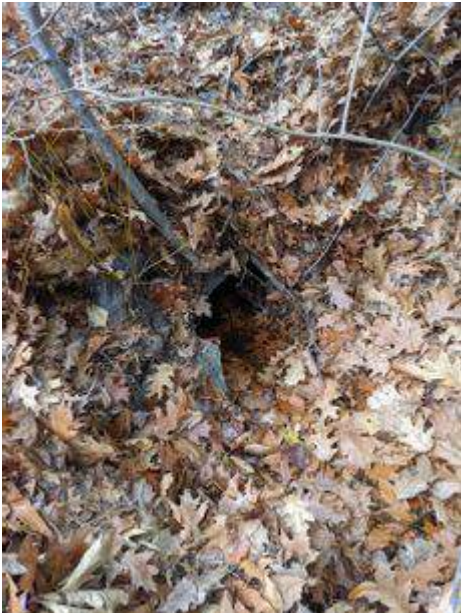
cul07 Outlet Pipe

<b>Outlet Type:</b>	Riprap Apron/Embankment		
<b>Outlet Condition?</b> Good		<b>Outlet Obstruction?</b> No	
<b>Vegetation removal needed?</b>		Yes	
<b>Additional Notes:</b>

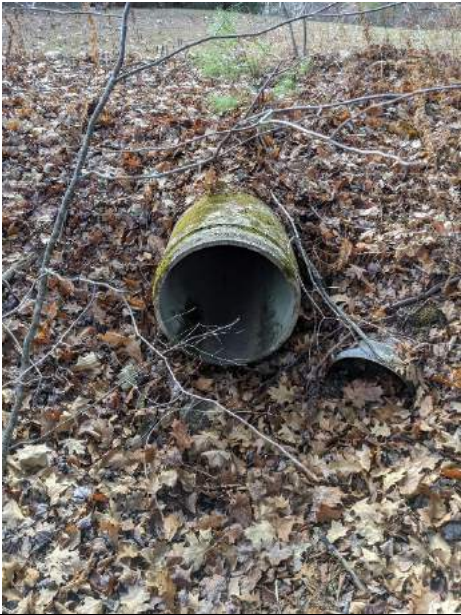
cul08 Outlet Pipe

<b>Outlet Type:</b>	Riprap Apron		
<b>Outlet Condition?</b> Poor	<b>Outlet Obstruction?</b> No		
<b>Vegetation removal needed?</b>	Yes		
<b>Additional Notes:</b>	two differnt pipes connected together

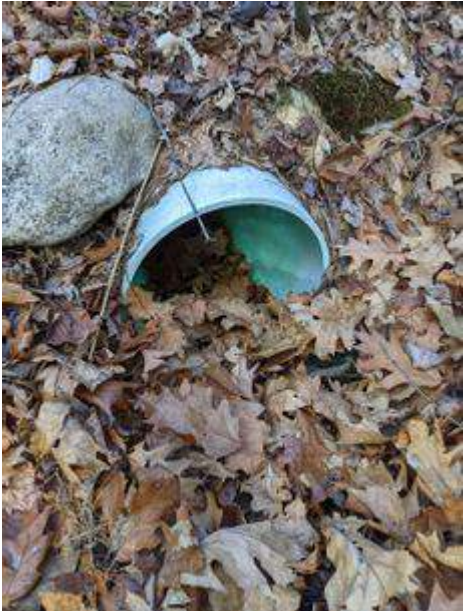
cul09 Inlet Pipe

<b>Does roadway have a history of flooding?</b>	No		
<b>Bed material within culvert:</b>	earth and rock		
<b>Tidal Influence?</b>	No		
<b>Additional Observations:</b>	Two Pipes, One 24" and One 48", Same Condition, Eroded Bottom		
<b>Is the culvert hanging?</b>	No		
<b>Is there evidence of high water above the top of the culvert?</b>	Yes		
<b>Addition Observation:</b>

<u>Description of Existing Culvert</u>			
<b>Culvert lining?</b>	No		
<b>Condition inside culvert:</b>	No – Cracking, No – Spalling, No – Abrasion, Yes – Corrosion, Yes – Joint Gaps or Open Seams		
<b>Box Culvert?</b> No	<b>Cracks vertical/horizontal on sides/walls?</b>	<b>Undermining of footing of three-sided culvert?</b>	<b>Exposed footings?</b>
<b>Culvert extended?</b> No	<b>Condition of extension:</b>  N/A		<b>Extension pipe smaller than original pipe?</b>  No
<b>Is there a line of sight along the crown and spring line?</b>			Yes
<b>Is the culvert shape deflected?</b>			Yes
<b>Is water seeping along the outside of the culvert (piping)?</b>			Yes
<b>Should the culvert be video inspected?</b>			No
<b>Addition Observation:</b>			
<u>Culvert Inlet</u>			
<b>Inlet Type:</b>	Riprap Apron/Embankment		
<b>Inlet Condition?</b> Poor	<b>Inlet Obstruction?</b> Yes		
<b>Vegetation removal needed?</b>	No		
<u>Culvert Outlet</u>

<b>Outlet Type:</b>	Riprap Apron/Embankment		
<b>Outlet Condition?</b> Poor	<b>Outlet Obstruction?</b> No		
<b>Vegetation removal needed?</b>	Yes		
<b>Additional Notes:</b>	pipes need to be replaced, undersized, eroded.

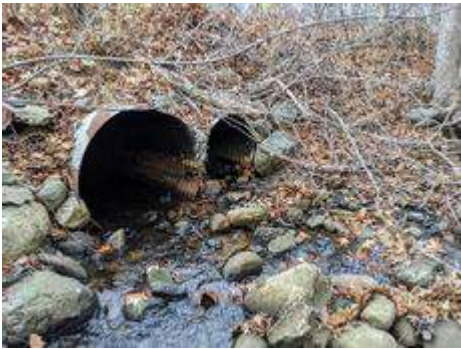
cul10 Outlet Pipe

<b>Outlet Type:</b>	Riprap Apron/Embankment		
<b>Outlet Condition?</b> Good		<b>Outlet Obstruction?</b> No	
<b>Vegetation removal needed?</b>		No	
<b>Additional Notes:</b>	some erosion at riprap

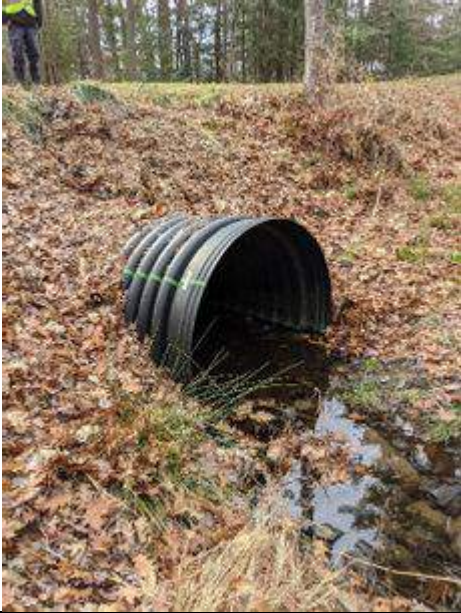
cul13 Inlet Pipe

<b>Size:</b>	48" & 24"	<b>Approximate Length:</b>	31'
<b>Does roadway have a history of flooding?</b>	No		
<b>Bed material within culvert:</b>	earth and rock		
<b>Tidal Influence?</b>	No		
<b>Additional Observations:</b>	Two Pipes, One 24" and One 48", Same Condition, Eroded Bottom, In Need of Repairs		
<b>Is the culvert hanging?</b>	No		
<b>Is there evidence of high water above the top of the culvert?</b>	Yes		
<b>Addition Observation:</b>

<u>Description of Existing Culvert</u>			
<b>Culvert lining?</b>	No		
<b>Condition inside culvert:</b>	No – Cracking, No – Spalling, No – Abrasion, Yes – Corrosion, Yes – Joint Gaps or Open Seams		
<b>Box Culvert?</b> No	<b>Cracks vertical/horizontal on sides/walls?</b>	<b>Undermining of footing of three-sided culvert?</b>	<b>Exposed footings?</b>
<b>Culvert extended?</b> No	<b>Condition of extension:</b>  N/A		<b>Extension pipe smaller than original pipe?</b>  No
<b>Is there a line of sight along the crown and spring line?</b>			Yes
<b>Is the culvert shape deflected?</b>			Yes
<b>Is water seeping along the outside of the culvert (piping)?</b>			Yes
<b>Should the culvert be video inspected?</b>			No
<b>Addition Observation:</b>			
<u><b>Culvert Inlet</b></u>			
<b>Inlet Type:</b>	Riprap Apron/Embankment		
<b>Inlet Condition?</b> Good		<b>Inlet Obstruction?</b> Yes	
<b>Vegetation removal needed?</b>		No

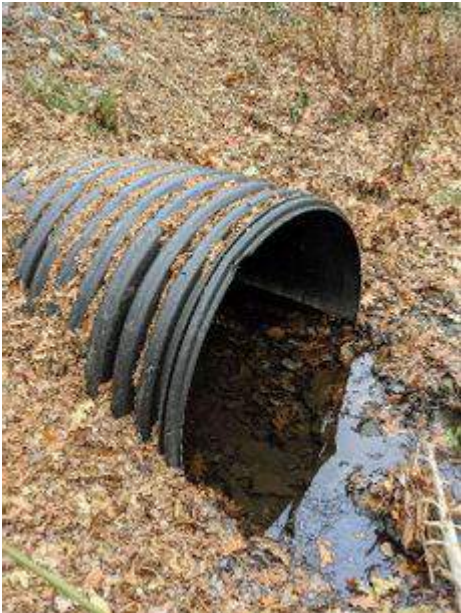
cul13 Outlet Pipe

<u><b>Culvert Outlet</b></u>			
<b>Outlet Type:</b>	Riprap Apron/Embankment		
<b>Outlet Condition?</b> Good		<b>Outlet Obstruction?</b> Yes	
<b>Vegetation removal needed?</b>		No	
<b>Additional Notes:</b>	bottom eroded, undersized, replace

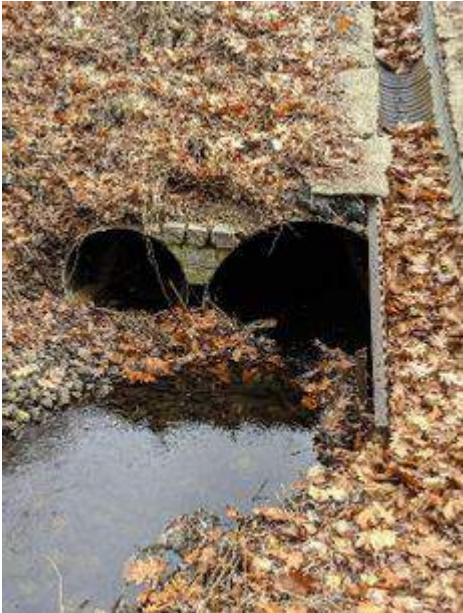
cul14 Inlet Pipe

<b>Does roadway have a history of flooding?</b>	No		
<b>Bed material within culvert:</b>	eroded		
<b>Tidal Influence?</b>	No		
<b>Additional Observations:</b>	Culvert Extension? Failed Pipe, Replace		
<b>Is the culvert hanging?</b>			No
<b>Is there evidence of high water above the top of the culvert?</b>			Yes
<b>Addition Observation:</b>

<u><b>Description of Existing Culvert</b></u>			
<b>Culvert lining?</b>	No		
<b>Condition inside culvert:</b>	No – Cracking, No – Spalling, No – Abrasion, Yes – Corrosion, Yes – Joint Gaps or Open Seams		
<b>Box Culvert?</b> No	<b>Cracks vertical/horizontal on sides/walls?</b>	<b>Undermining of footing of three-sided culvert?</b>	<b>Exposed footings?</b>
<b>Culvert extended?</b> Yes	<b>Condition of extension:</b> Poor		<b>Extension pipe smaller than original pipe?</b> No
<b>Is there a line of sight along the crown and spring line?</b>			No
<b>Is the culvert shape deflected?</b>			Yes
<b>Is water seeping along the outside of the culvert (piping)?</b>			Yes
<b>Should the culvert be video inspected?</b>			No
<b>Addition Observation:</b>			
<u><b>Culvert Inlet</b></u>			
<b>Inlet Type:</b>	Riprap Apron/Embankment		
<b>Inlet Condition?</b> Poor		<b>Inlet Obstruction?</b> Yes	
<b>Vegetation removal needed?</b>		Yes

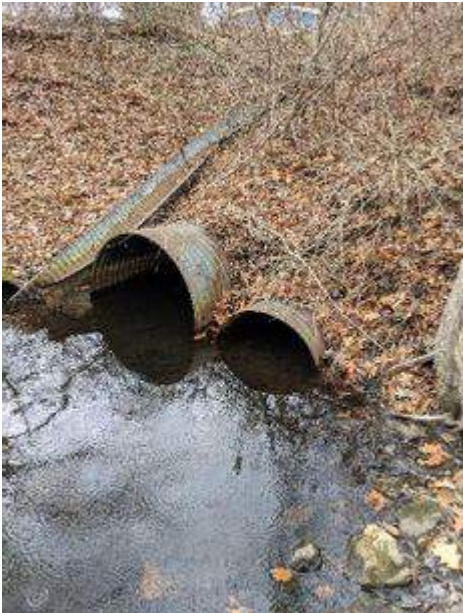
cul14 Outlet Pipe

<u><b>Culvert Outlet</b></u>			
<b>Outlet Type:</b>	Riprap Apron/Embankment		
<b>Outlet Condition?</b> Poor		<b>Outlet Obstruction?</b> Yes	
<b>Vegetation removal needed?</b>		Yes	
<b>Additional Notes:</b>	failed culvert, might be extended

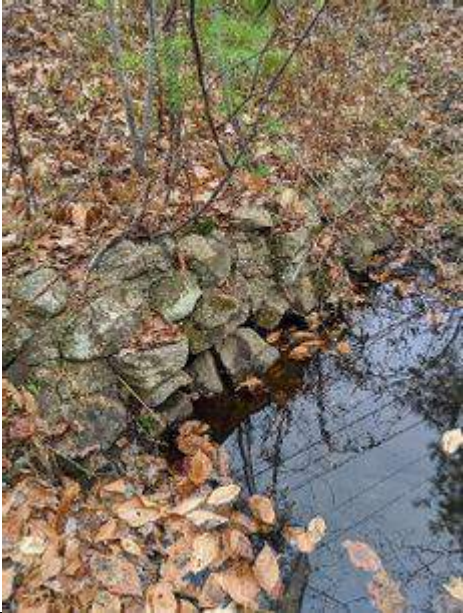
cul15 Outlet Pipe

<u><b>Culvert Outlet</b></u>			
<b>Outlet Type:</b>	Riprap Apron/Embankment		
<b>Outlet Condition?</b> Fair		<b>Outlet Obstruction?</b> No	
<b>Vegetation removal needed?</b>		Yes	
<b>Additional Notes:</b>	cribstone embankment at outlet

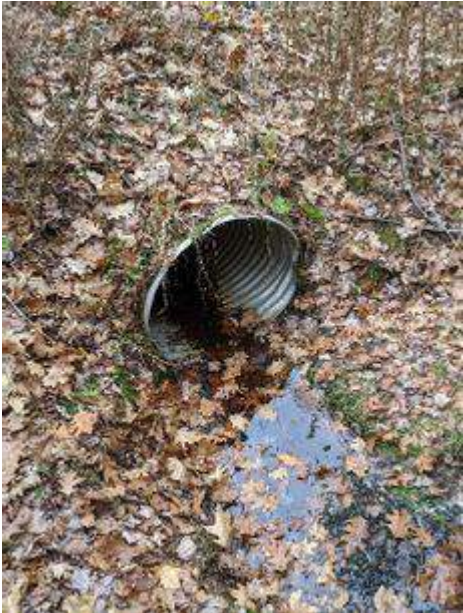
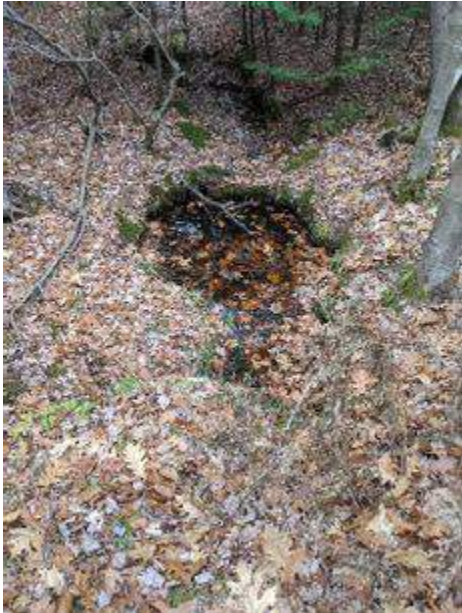
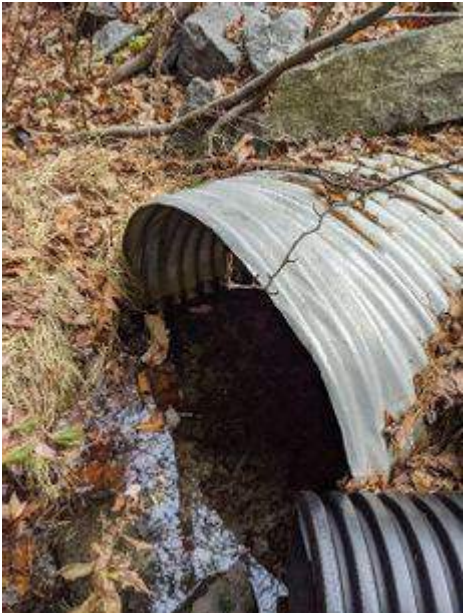
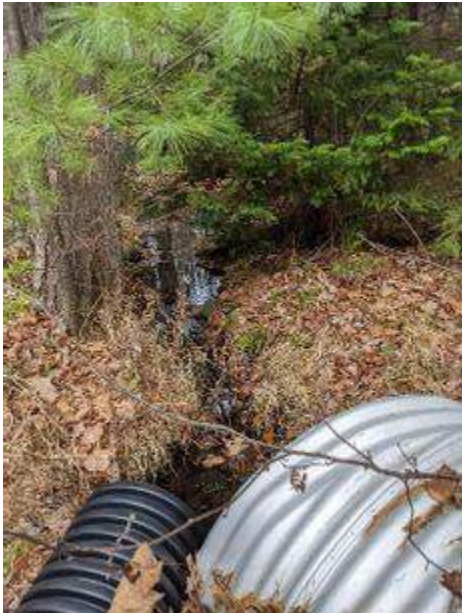
<u><b>Culvert Outlet</b></u>			
<b>Outlet Type:</b>	Riprap Apron/Embankment		
<b>Outlet Condition?</b> Good		<b>Outlet Obstruction?</b> No	
<b>Vegetation removal needed?</b>		No	
<b>Additional Notes:</b>	inlet pipe damaged but still functional

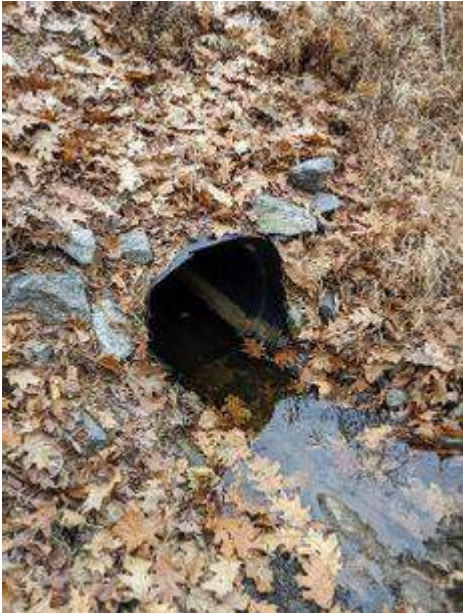
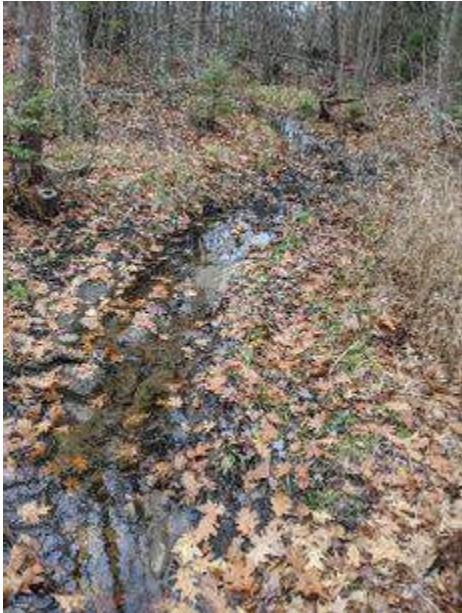
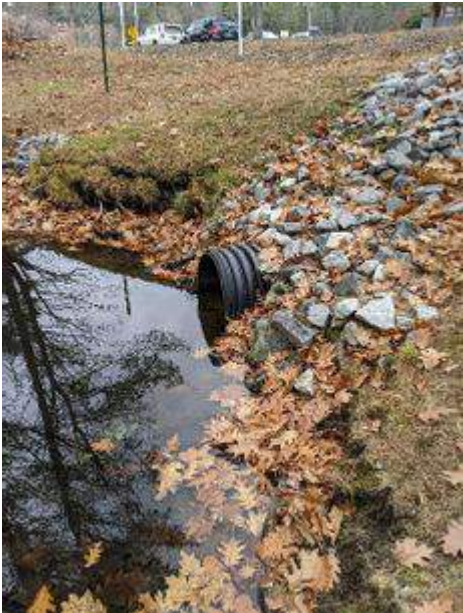
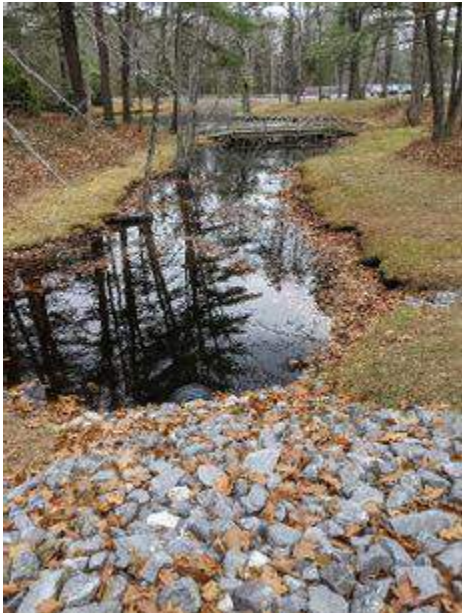
<b>Outlet Type:</b>	Riprap Apron/Embankment		
<b>Outlet Condition?</b> Fair		<b>Outlet Obstruction?</b> Yes	
<b>Vegetation removal needed?</b>		No	
<b>Additional Notes:</b>	inlet control structure from pond, some obstruction at pipe outlet

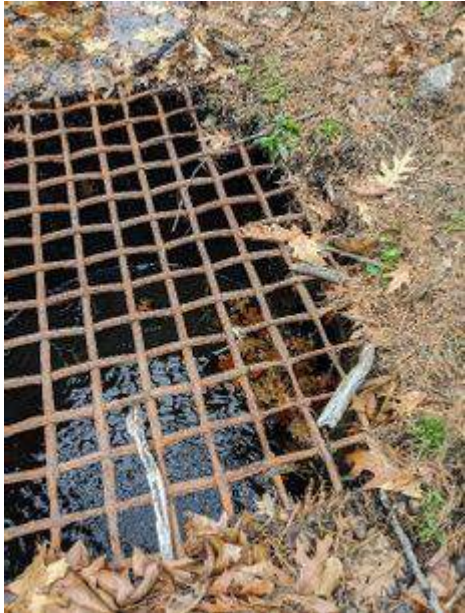
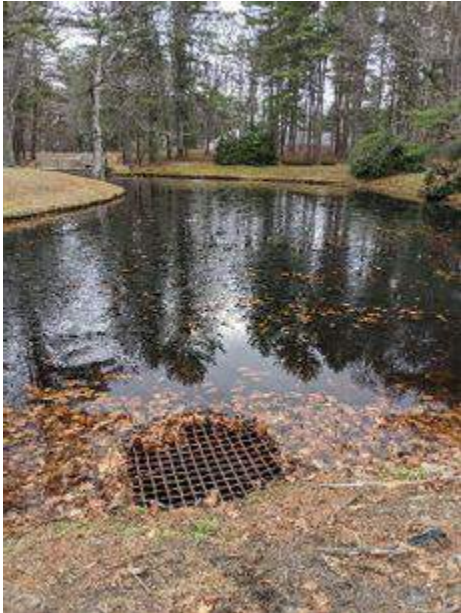
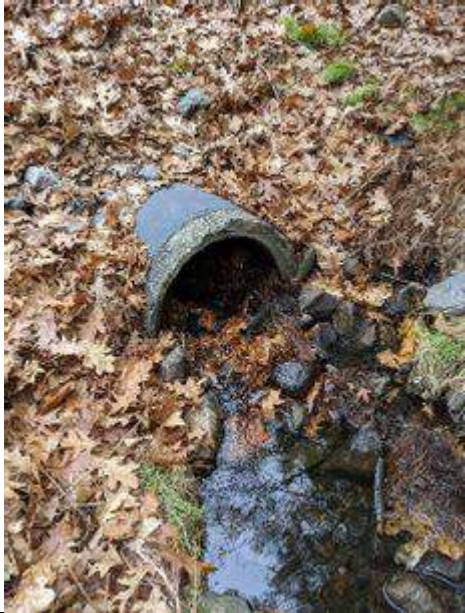
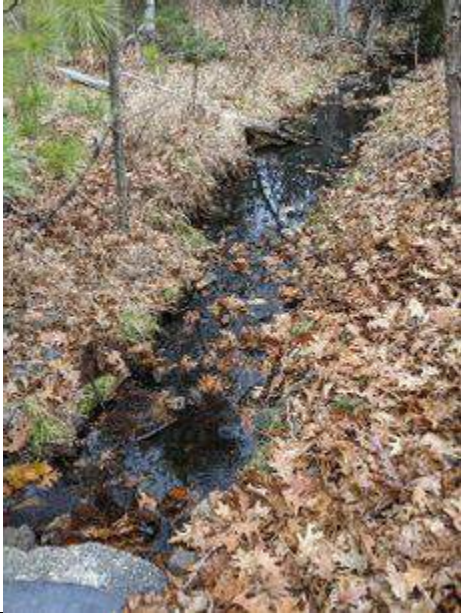
<u>Description of Existing Culvert</u>			
<b>Culvert lining?</b>	No		
<b>Condition inside culvert:</b>	No – Cracking, No – Spalling, No – Abrasion, Yes – Corrosion, Yes – Joint Gaps or Open Seams		
<b>Box Culvert?</b> No	<b>Cracks vertical/horizontal on sides/walls?</b>	<b>Undermining of footing of three-sided culvert?</b>	<b>Exposed footings?</b>
<b>Culvert extended?</b> No	<b>Condition of extension:</b>  N/A		<b>Extension pipe smaller than original pipe?</b>  No
<b>Is there a line of sight along the crown and spring line?</b>			Yes
<b>Is the culvert shape deflected?</b>			Yes
<b>Is water seeping along the outside of the culvert (piping)?</b>			Yes
<b>Should the culvert be video inspected?</b>			No
<b>Addition Observation:</b>			
<u>Culvert Inlet</u>			
<b>Inlet Type:</b>	Riprap Apron/Embankment		
<b>Inlet Condition?</b> Poor		<b>Inlet Obstruction?</b> Yes	
<b>Vegetation removal needed?</b>		Yes	
<u>Culvert Outlet</u>

<b>Outlet Type:</b>	Riprap Apron/Embankment		
<b>Outlet Condition?</b> Poor		<b>Outlet Obstruction?</b> No	
<b>Vegetation removal needed?</b>		No	
<b>Additional Notes:</b>	erosion, undersized, debris present, grate ripped off inlet

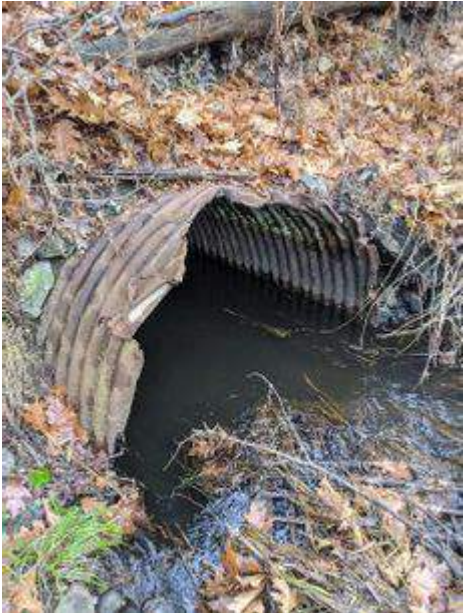
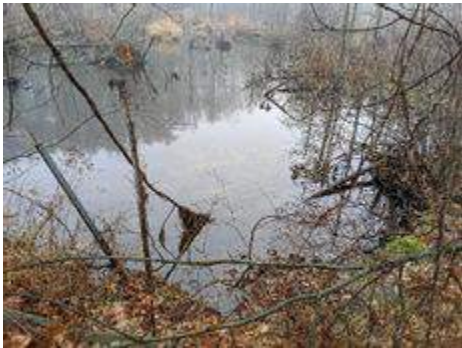
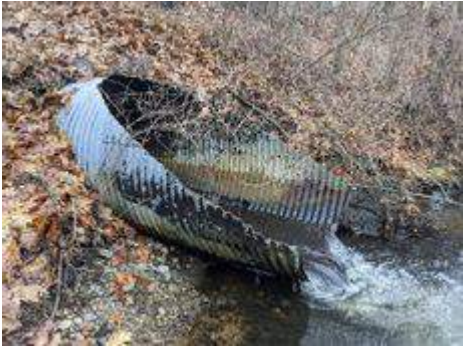
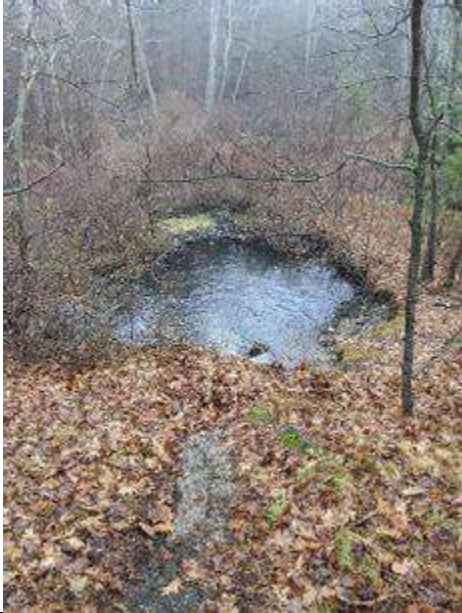
<u><b>Culvert Outlet</b></u>			
<b>Outlet Type:</b>	Riprap Apron/Embankment		
<b>Outlet Condition?</b> Good		<b>Outlet Obstruction?</b> No	
<b>Vegetation removal needed?</b>		Yes	
<b>Additional Notes:</b>	erosion around outlet, 4 ft overhang, debris in stream

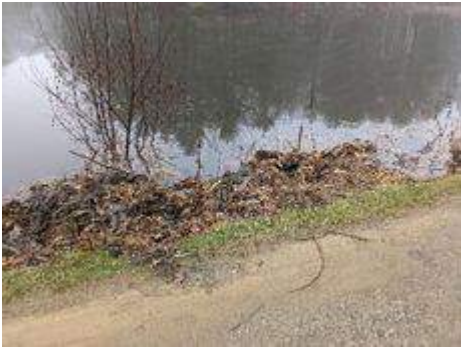
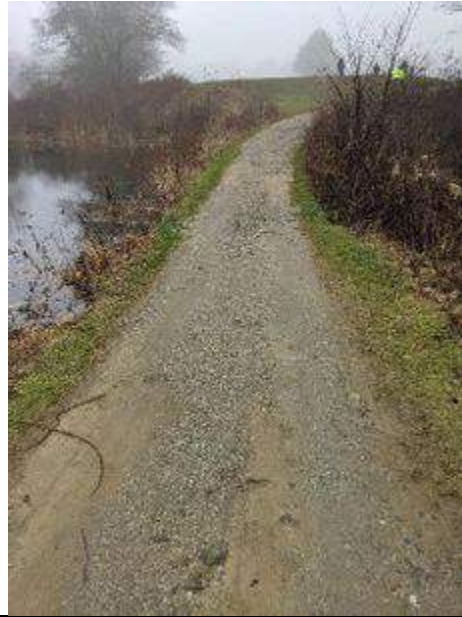
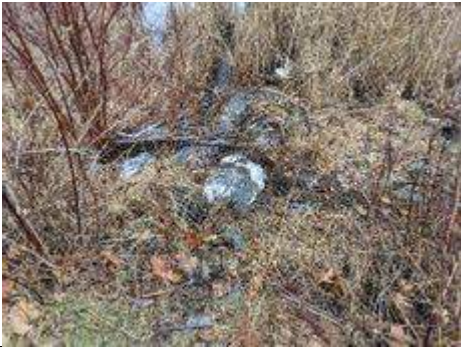
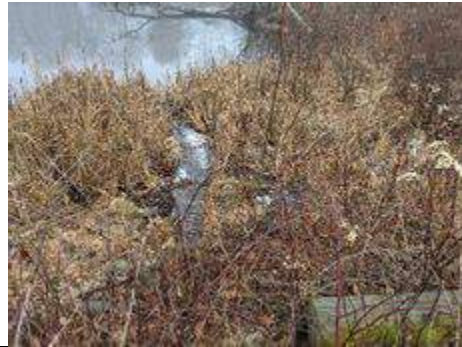
<b>Does roadway have a history of flooding?</b>	Yes		
<b>Bed material within culvert:</b>	N/A		
<b>Tidal Influence?</b>	No		
<b>Additional Observations:</b>	Multiple Pipes, Same Condition, Massive Blockage, Poor Inlet Flow		
<b>Is the culvert hanging?</b>			Yes
<b>Is there evidence of high water above the top of the culvert?</b>			Yes
<b>Addition Observation:</b>

<b>Outlet Type:</b>	Riprap Apron		
<b>Outlet Condition?</b> Poor	<b>Outlet Obstruction?</b> Yes		
<b>Vegetation removal needed?</b>	Yes		
<b>Additional Notes:</b>	road blocking stream, undersized, poor outlet condition, needs to be addressed

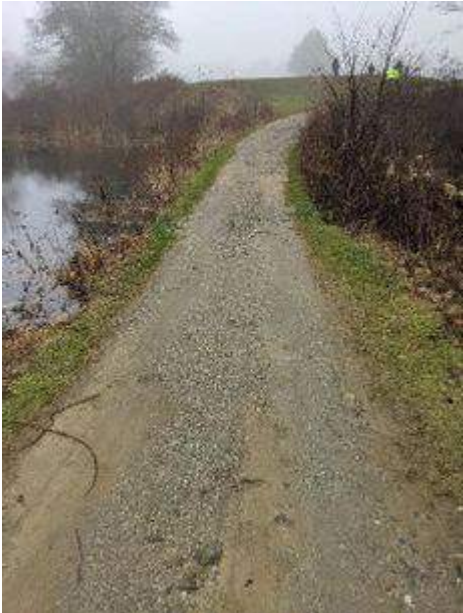
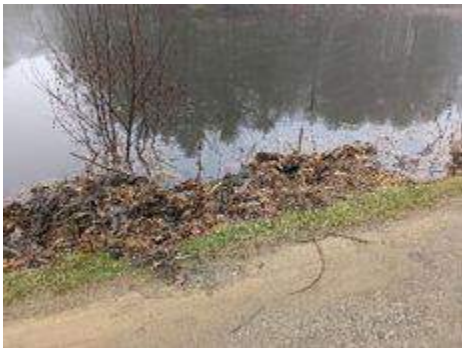
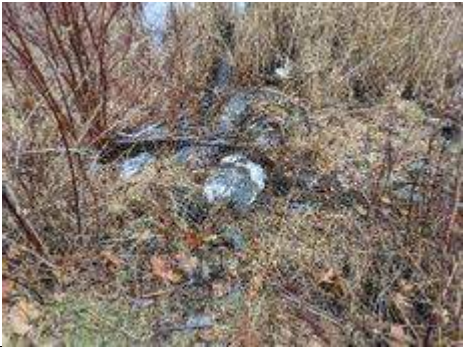
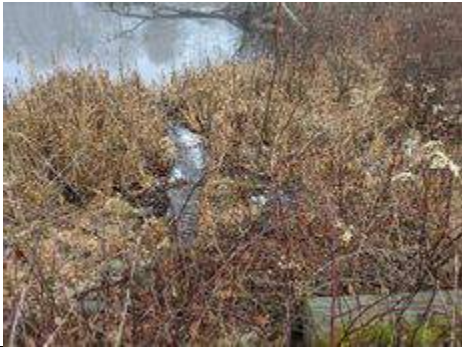
<b>Does roadway have a history of flooding?</b>	Yes		
<b>Bed material within culvert:</b>	N/A		
<b>Tidal Influence?</b>	No		
<b>Additional Observations:</b>	Multiple Pipes, Same Condition, Massive Blockage, Poor Inlet Flow		
<b>Is the culvert hanging?</b>		Yes	
<b>Is there evidence of high water above the top of the culvert?</b>		Yes	
<b>Addition Observation:</b>

<b>Outlet Type:</b>	Riprap Apron		
<b>Outlet Condition?</b> Poor	<b>Outlet Obstruction?</b> Yes		
<b>Vegetation removal needed?</b>	Yes		
<b>Additional Notes:</b>	road blocking stream, undersized, poor outlet condition, needs to be addressed
