# Mare Brook Watershed Management Plan

2022-2032

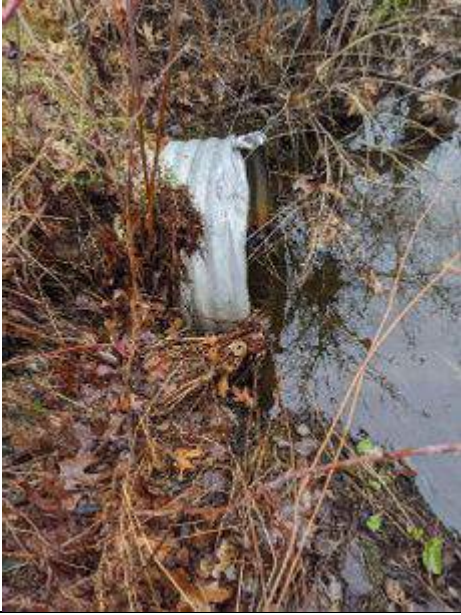
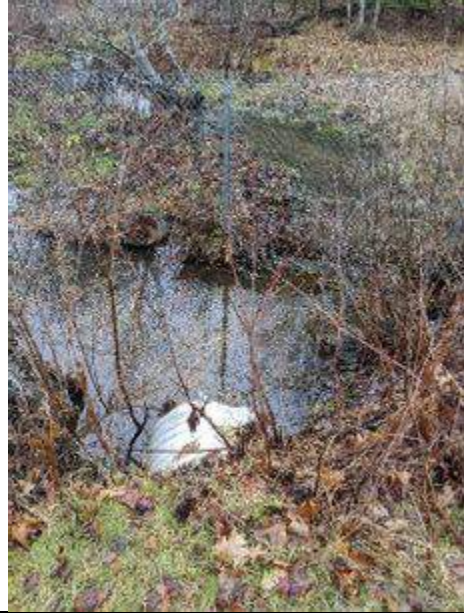
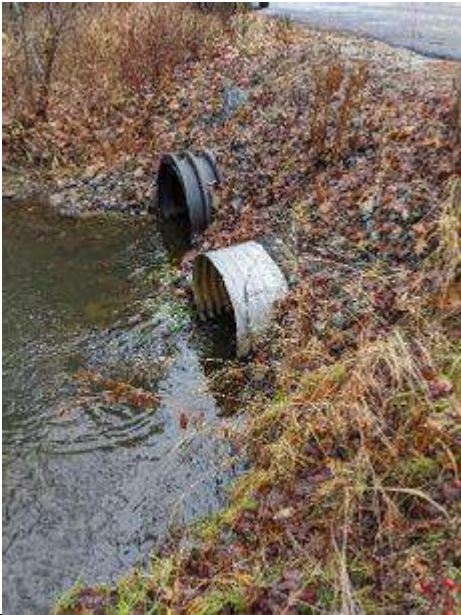
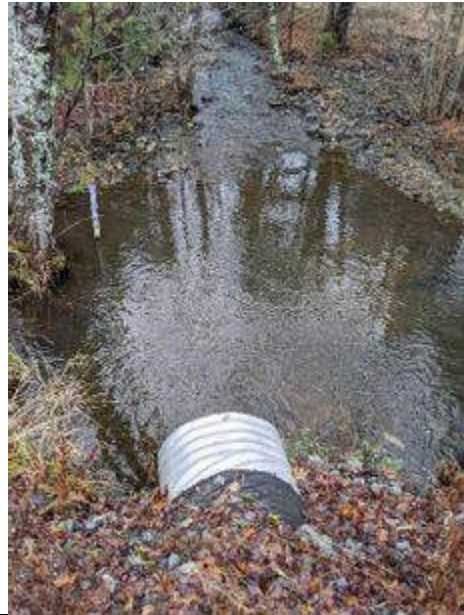
<u><b>Culvert Outlet</b></u>			
<b>Outlet Type:</b>	Riprap Apron/Embankment		
<b>Outlet Condition?</b> Good		<b>Outlet Obstruction?</b> No	
<b>Vegetation removal needed?</b>		No	
<b>Additional Notes:</b>	erosion around outside of culvert

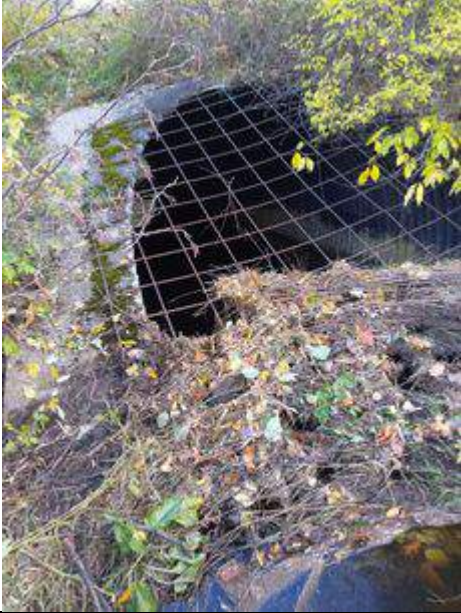
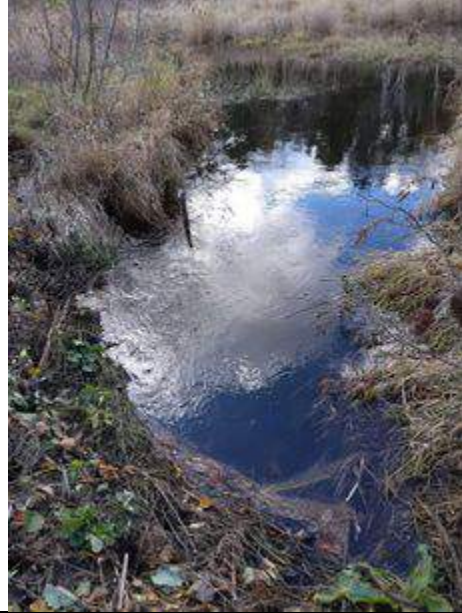
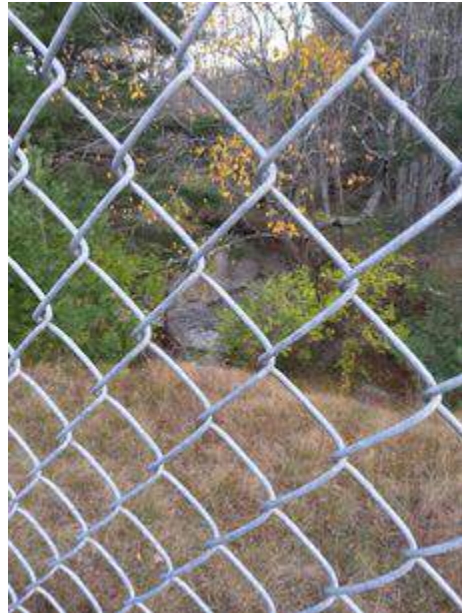
cul29 Inlet Pipe

<u><b>Description of Existing Culvert</b></u>			
<b>Culvert lining?</b>	No		
<b>Condition inside culvert:</b>	No – Cracking, No – Spalling, No – Abrasion, No – Corrosion, No – Joint Gaps or Open Seams		
<b>Box Culvert?</b> No	<b>Cracks vertical/horizontal on sides/walls?</b> No	<b>Undermining of footing of three-sided culvert?</b> No	<b>Exposed footings?</b> No
<b>Culvert extended?</b> No	<b>Condition of extension:</b> N/A		<b>Extension pipe smaller than original pipe?</b> No
<b>Is there a line of sight along the crown and spring line?</b>			Yes
<b>Is the culvert shape deflected?</b>			No
<b>Is water seeping along the outside of the culvert (piping)?</b>			No
<b>Should the culvert be video inspected?</b>			No
<b>Addition Observation:</b>			
<u><b>Culvert Inlet</b></u>			
<b>Inlet Type:</b>	Concrete Wingwall		
<b>Inlet Condition?</b> Fair		<b>Inlet Obstruction?</b> Yes	
<b>Vegetation removal needed?</b>		Yes

<u><b>Culvert Outlet</b></u>			
<b>Outlet Type:</b>	Concrete Wingwall		
<b>Outlet Condition?</b> Fair		<b>Outlet Obstruction?</b> Yes	
<b>Vegetation removal needed?</b>		Yes	
<b>Additional Notes:</b>	Concrete wigwalls, some vegetation blocking inlet and outlet, trash/animal guard. outlet inaccessible

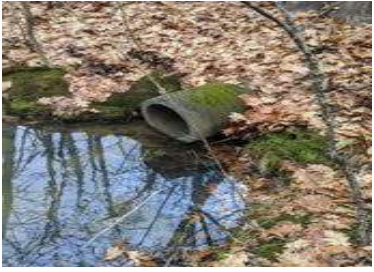
12	At Harpswell Road Crossing	24	Corrugated Metal Pipe / Round	<ul style="list-style-type: none"> <li>• Significant sediment at inlet</li> <li>• Pipe structure in fair shape</li> <li>• Restricted flow due to sediment</li> </ul>	Clear sediment at inlet and outlet	Town labor	Low \$500

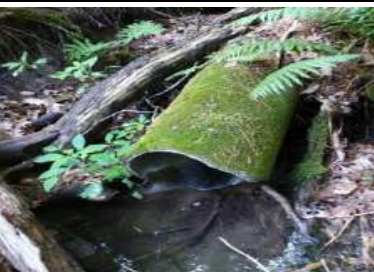
17	Off Sparwell Lane	15	Clay Pipe Round	<ul style="list-style-type: none"> <li>• Adequately sized</li> <li>• Pipe structure in bad shape</li> <li>• Pipe section missing and erosion at outlet</li> </ul>	Retrofit outlet with new section and outlet protection	Town permitting and labor	Moderate \$10 - 12K with Town Labor

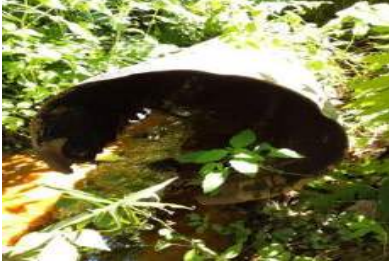
21	Off Magean Street	15	Corrugated Metal Pipe / Round	<ul style="list-style-type: none"> <li>• Pipe rusted and failing</li> <li>• Outlet structure needs to be replaced</li> </ul>	Replace outfall pipe and add new structure	Town permitting and labor/Private land	Moderate \$15,000 - 20,000 with Town Labor

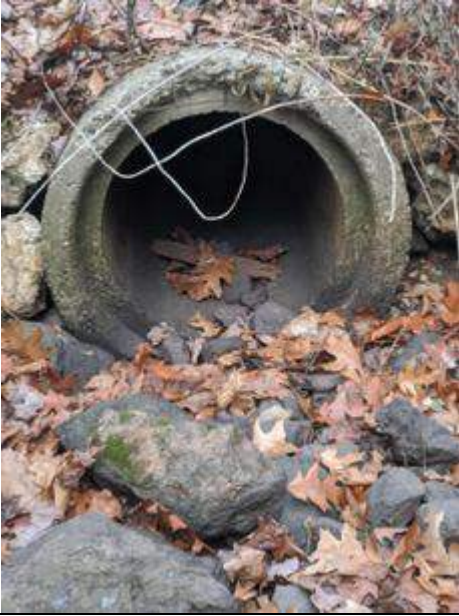
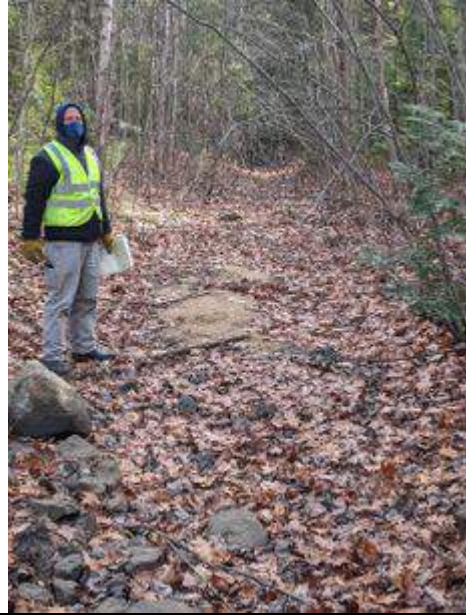
out11

Outfall #	Location	Size (in)	Material/Shape	Condition	Recommendation	Requirements	Estimated Cost <sup>†</sup>	Ground photo
11	Western basin outlet	24	Reinforced Concrete Pipe / Round	<ul style="list-style-type: none"> <li>• Adequately sized</li> <li>• Pipe structure in good shape</li> <li>• Limited erosion at outlet</li> </ul>	None	Not applicable	None at this time

<b>Sediment Condition:</b> Open	<b>Structure Condition:</b> Good
<b>Trash/Litter:</b> No	<b>Yard Waste Observed:</b> No
<b>General Comments:</b> sediment in channel	
<b>Actions Taken:</b> none	
<b>Follow-up Required?</b> No

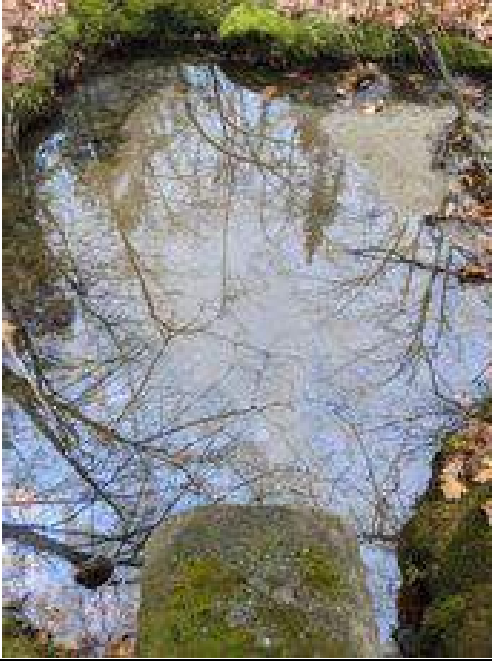
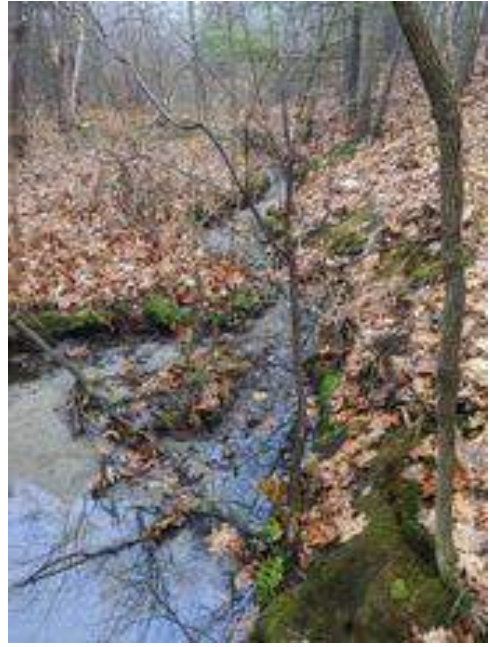
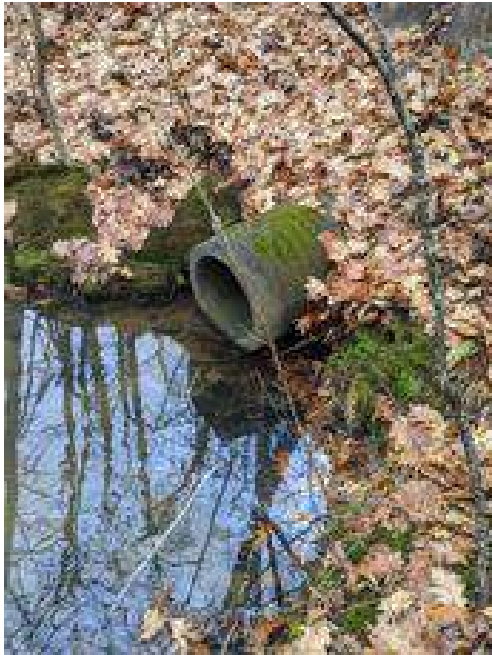
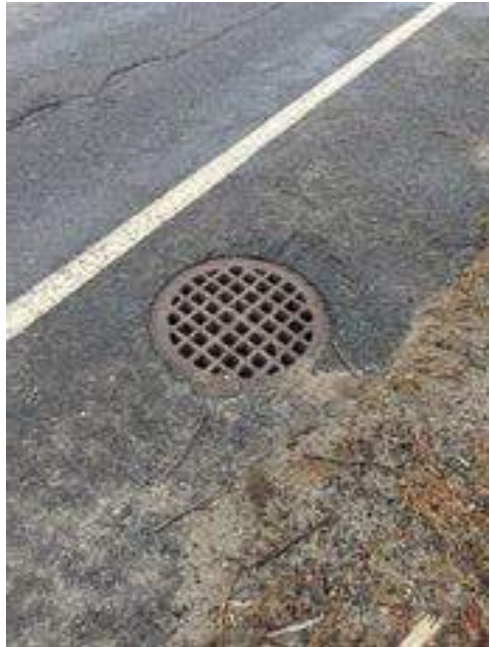
out12

<b>Sediment Condition:</b> 1/2 Full	<b>Structure Condition:</b> Fair
<b>Trash/Litter:</b> No	<b>Yard Waste Observed:</b> No
<b>General Comments:</b> lots of sediment backing up flow	
<b>Actions Taken:</b> none	
<b>Follow-up Required?</b> No

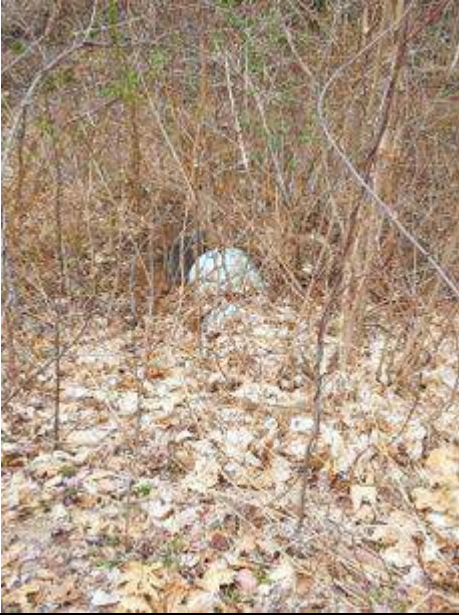
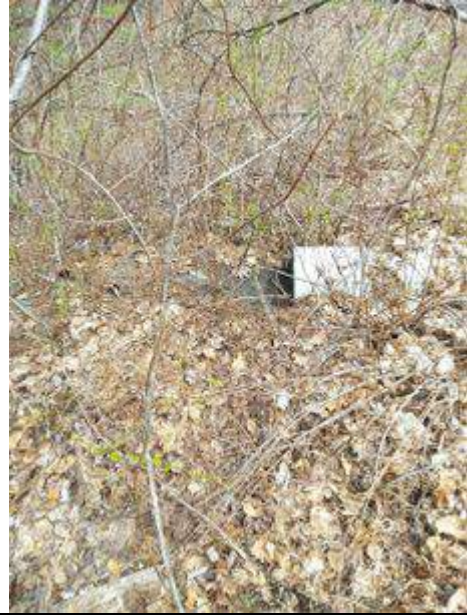
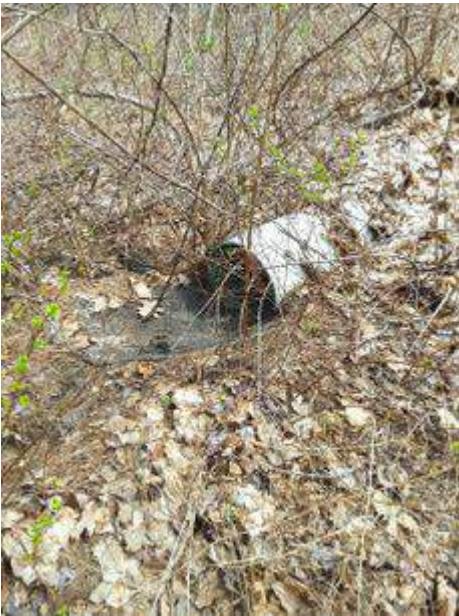
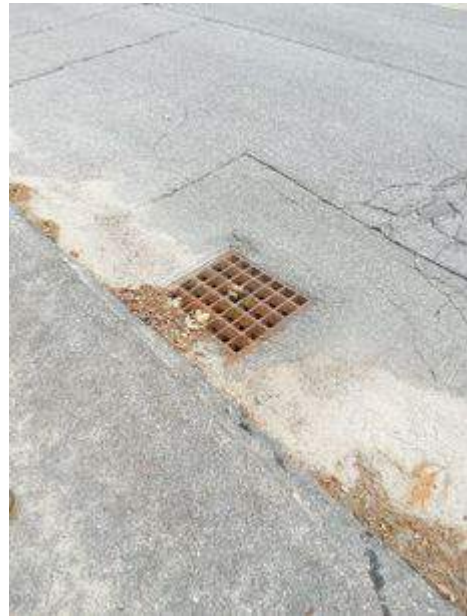
out13

13	Macmillan Drive Crossing	15	PVC Pipe / Round	<ul style="list-style-type: none"> <li>• Significant sediment at inlet</li> <li>• Pipe structure in good shape</li> <li>• Restricted flow due to sediment build-up</li> </ul>	Clear sediment at catch basin and pipe	Town labor	Low \$500

<b>Sediment Condition:</b> Full	<b>Structure Condition:</b> Good
<b>Trash/Litter:</b> No	<b>Yard Waste Observed:</b> No
<b>General Comments:</b> Catch basin with limited sump, sediment in outfall	
<b>Actions Taken:</b> No	
<b>Follow-up Required?</b> No

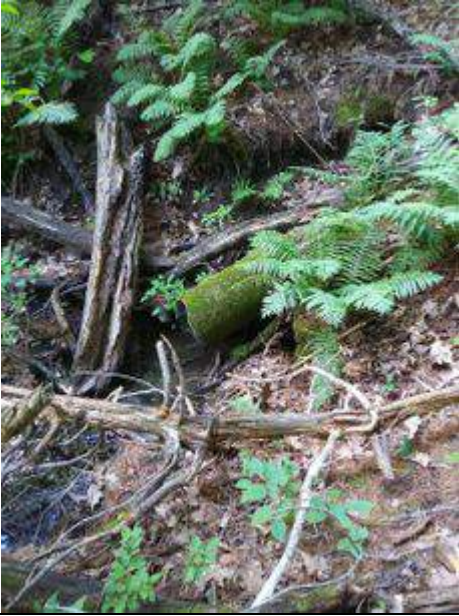
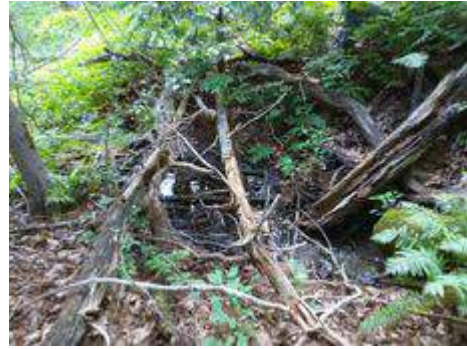
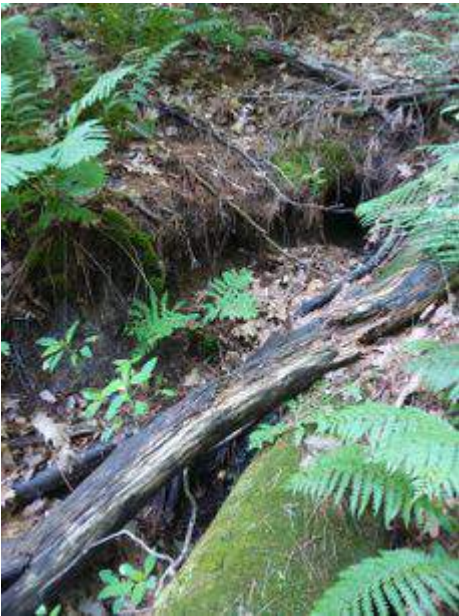
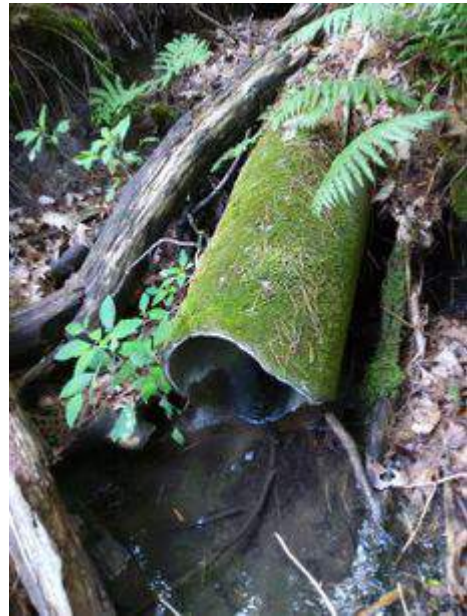
out17

<b>Sediment Condition:</b> Open	<b>Structure Condition:</b> Poor
<b>Trash/Litter:</b> No	<b>Yard Waste Observed:</b> Yes
<b>General Comments:</b> Pipe in bad condition, lots of erosion around pipe.	
<b>Actions Taken:</b> None, needs to be addresses	
<b>Follow-up Required?</b> Yes

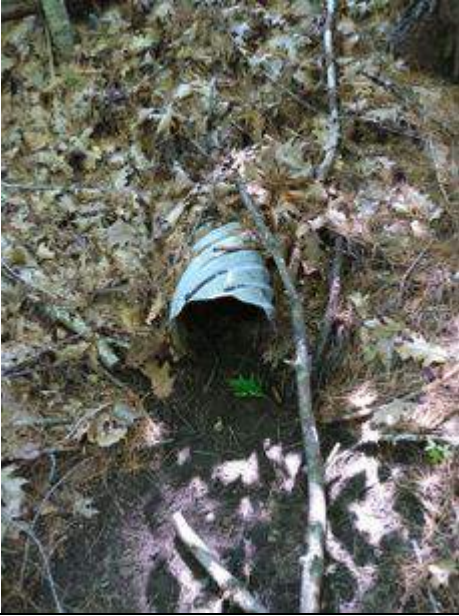
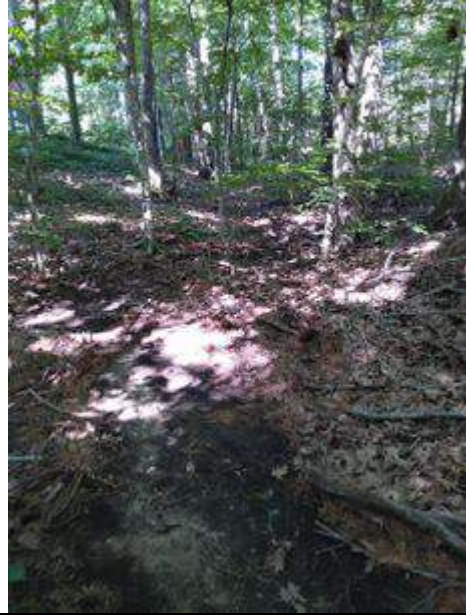
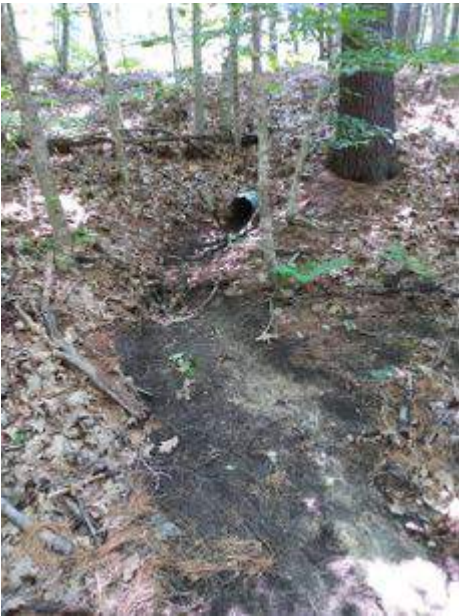
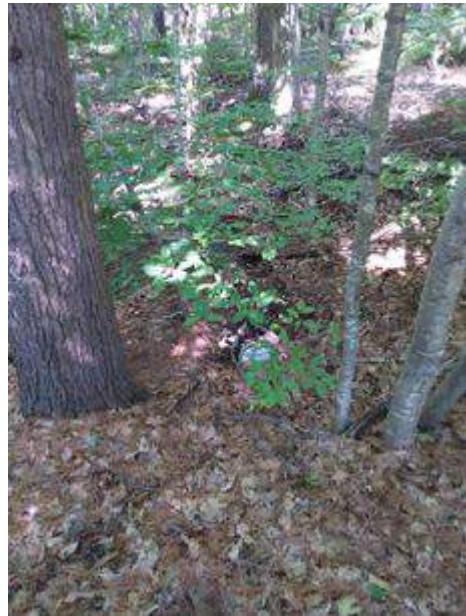
out18

Outfall #	Location	Size (in)	Material/Shape	Condition	Recommendation	Requirements	Estimated Cost <sup>†</sup>	Ground photo
18	Off Hemlock Road	12	Corrugated Metal Pipe Round	<ul style="list-style-type: none"> <li>• Adequately sized</li> <li>• Pipe structure in fair shape</li> <li>• Sediment at outlet</li> </ul>	Remove sediment build-up and retrofit outlet with riprap protection	Town permitting and labor	Low \$500 - 1,000 with Town Labor

<b>Sediment Condition:</b> 1/4 Full	<b>Structure Condition:</b> Fair
<b>Trash/Litter:</b> No	<b>Yard Waste Observed:</b> Yes
<b>General Comments:</b> Add outlet treatment	
<b>Actions Taken:</b> None	
<b>Follow-up Required?</b> No

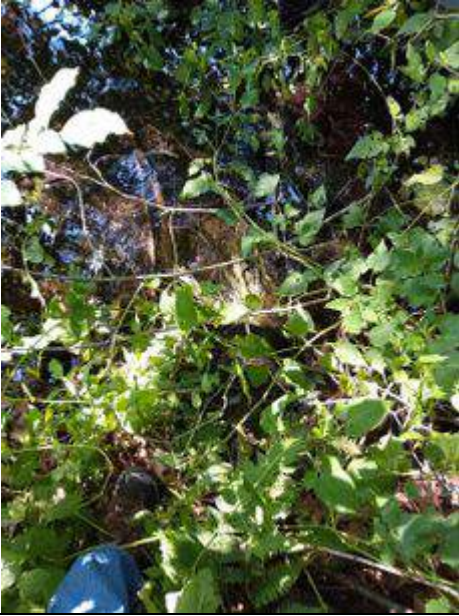
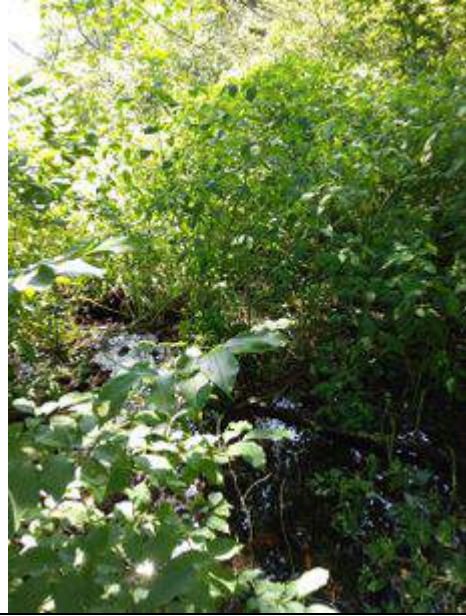
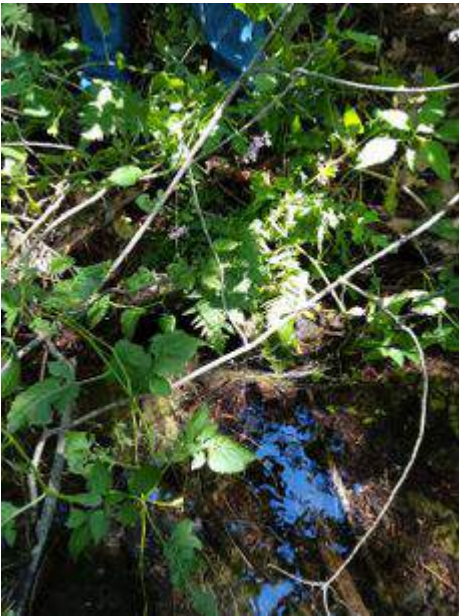
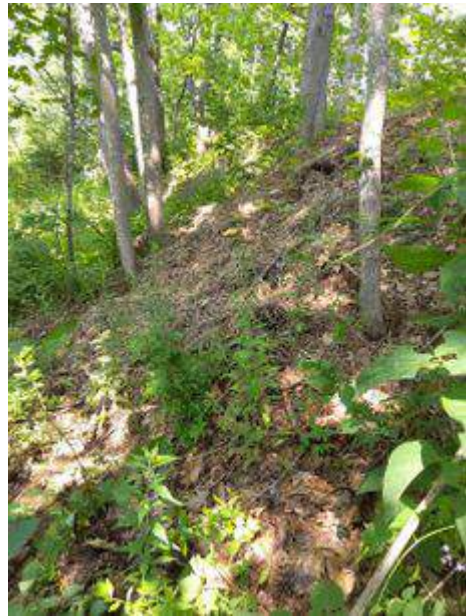
out19

19	Off Breckam Road	12	Clay Pipe / Round	<ul style="list-style-type: none"> <li>• Adequately sized</li> <li>• Pipe structure in poor shape</li> <li>• Submerged at outlet, heavy vegetation</li> </ul>	Replace outfall pipe and provide outlet protection	Town permitting and labor/Private land	Moderate \$10,000 - 15,000 with Town Labor

<b>Sediment Condition:</b> 1/4 Full	<b>Structure Condition:</b> Poor
<b>Trash/Litter:</b> No	<b>Yard Waste Observed:</b> Yes
<b>General Comments:</b> Old clay pipe, partially submerged, lots of vegetation, invasive	
<b>Actions Taken:</b> None	
<b>Follow-up Required?</b> Yes

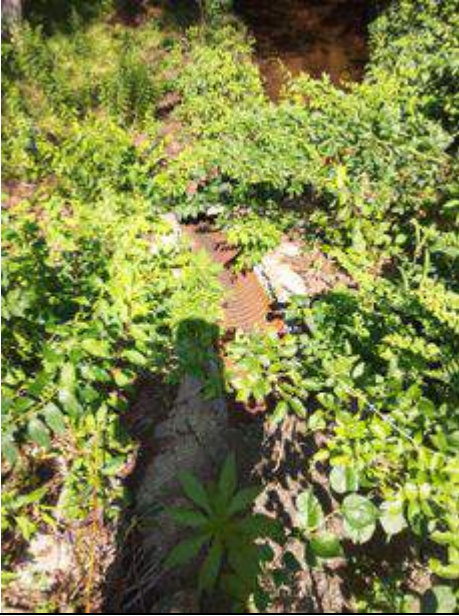
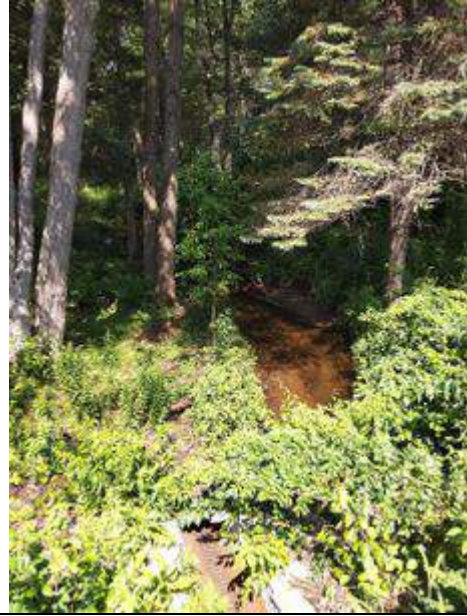
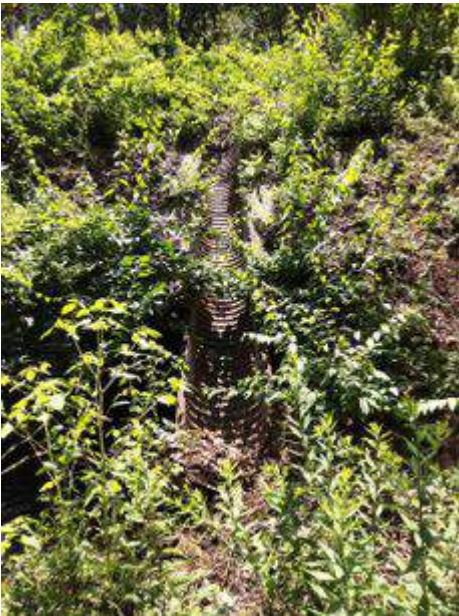
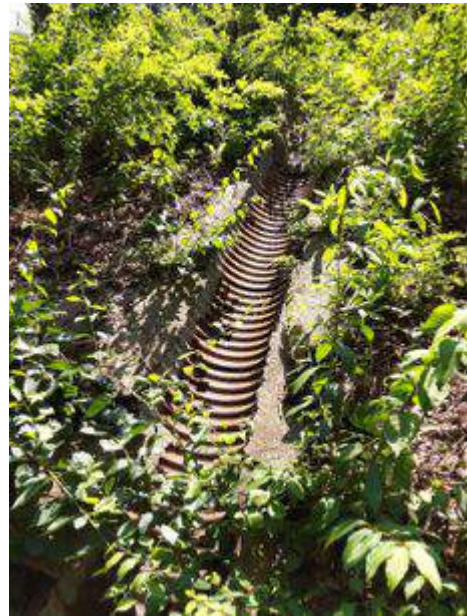
out20

20	Off MacMillan Drive	18	Corrugated Metal Pipe & Concrete / 1/2 circle	<ul style="list-style-type: none"> <li>• Concrete foundation failing</li> <li>• Sediment at outlet and in stream</li> </ul>	Remove outfall and replace with road catch basin	Town permitting and labor	Moderate \$12,500 - 17,500 with Town Labor

<b>Sediment Condition:</b> Open	<b>Structure Condition:</b> Poor
<b>Trash/Litter:</b> No	<b>Yard Waste Observed:</b> No
<b>General Comments:</b> Replace outfall	
<b>Actions Taken:</b> None	
<b>Follow-up Required?</b> Yes

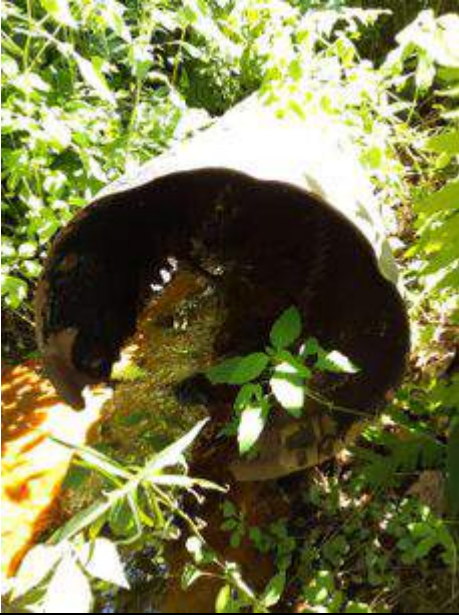
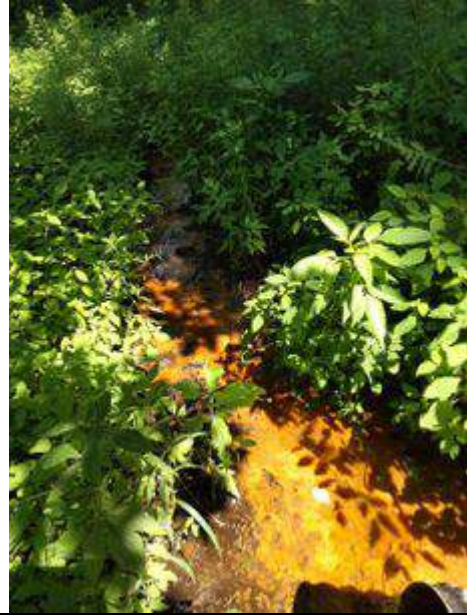
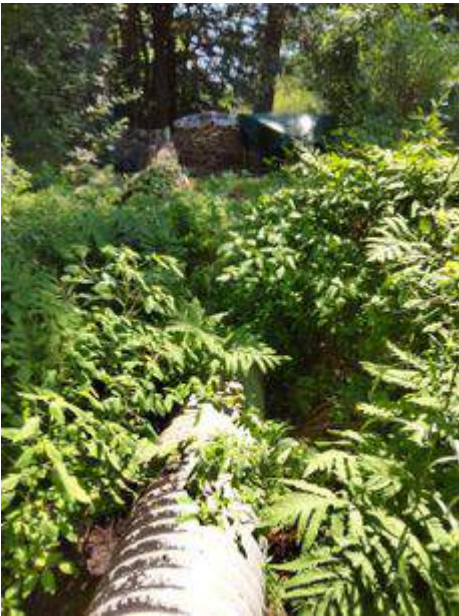
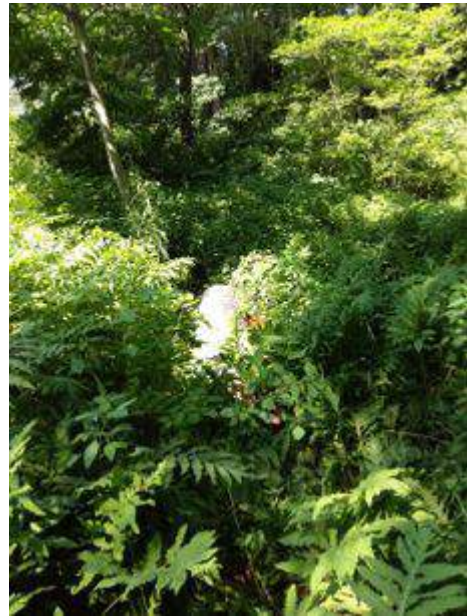
out21

<b>Sediment Condition:</b> Open	<b>Structure Condition:</b> Poor
<b>Trash/Litter:</b> No	<b>Yard Waste Observed:</b> Yes
<b>General Comments:</b> Rusted on bottom	
<b>Actions Taken:</b> No	
<b>Follow-up Required?</b> Yes

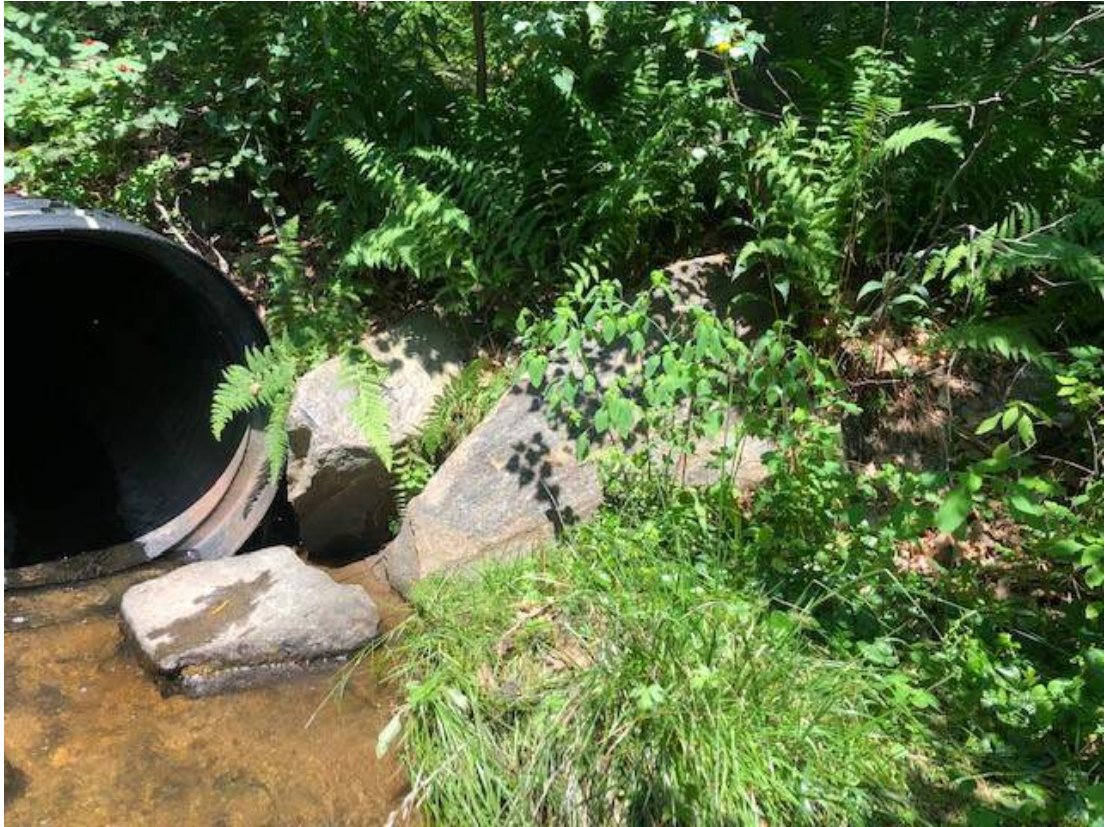
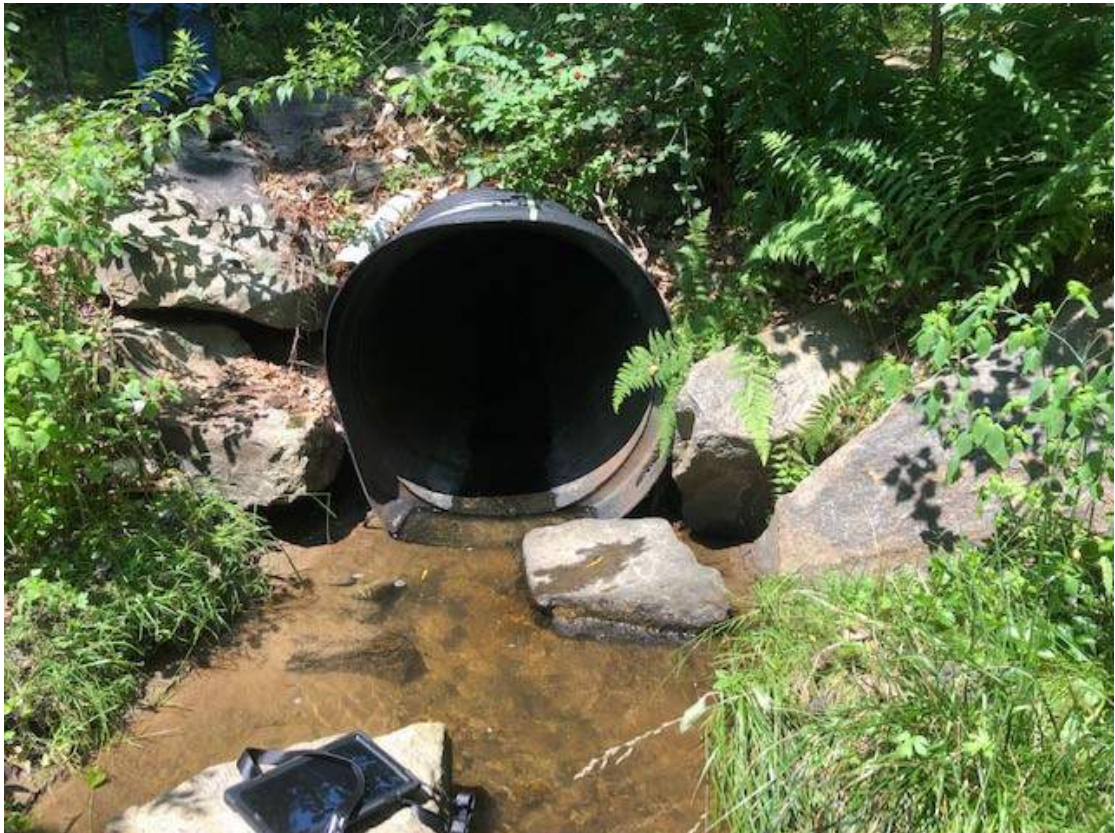
out22

Outfall #	Location	Size (in)	Material/Shape	Condition	Recommendation	Requirements	Estimated Cost <sup>†</sup>	Ground photo
22	Off Arrowhead Drive	36	PE N-12 Pipe / Round	<ul style="list-style-type: none"> <li>• Adequately sized</li> <li>• Pipe structure in good shape</li> <li>• No erosion at outlet</li> </ul>	None	Not applicable	None at this time

<b>Sediment Condition:</b> Open	<b>Structure Condition:</b> Good
<b>Trash/Litter:</b> No	<b>Yard Waste Observed:</b> No
<b>General Comments:</b> None	
<b>Actions Taken:</b> None	
<b>Follow-up Required?</b> No

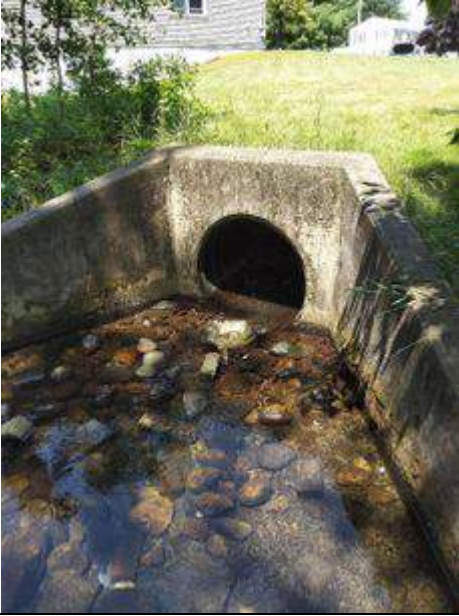
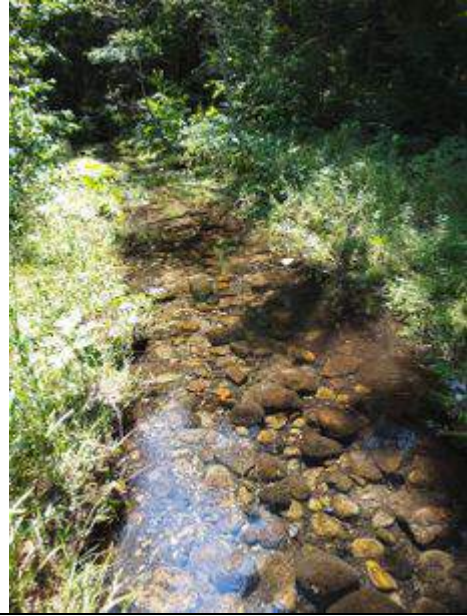
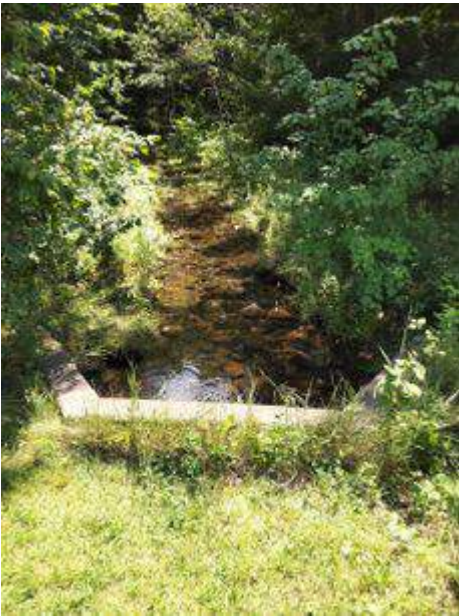
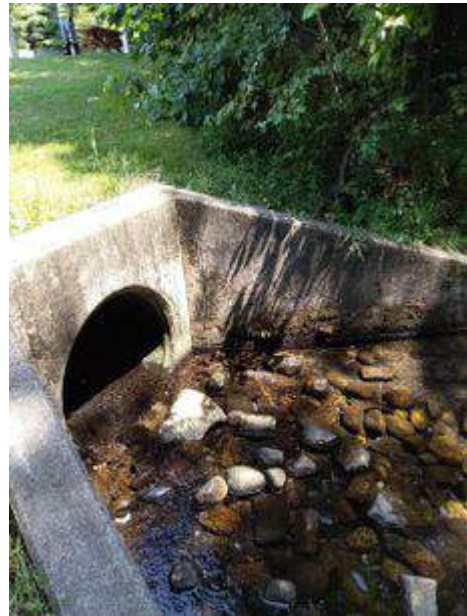
out23

<b>Sediment Condition:</b> Open	<b>Structure Condition:</b> Good
<b>Trash/Litter:</b> No	<b>Yard Waste Observed:</b> No
<b>General Comments:</b> Perfect Outfall	
<b>Actions Taken:</b> None	
<b>Follow-up Required?</b> No
